# UNIVERSITY OF FLORIDA

**UF - 656 LMP IMPLEMENTATION  
LVL COMMITTEE / DESIGN DEVELOPMENT**

# ARCHER ROAD AGRONOMY COMPLEX

## Maintenance Tree Removal

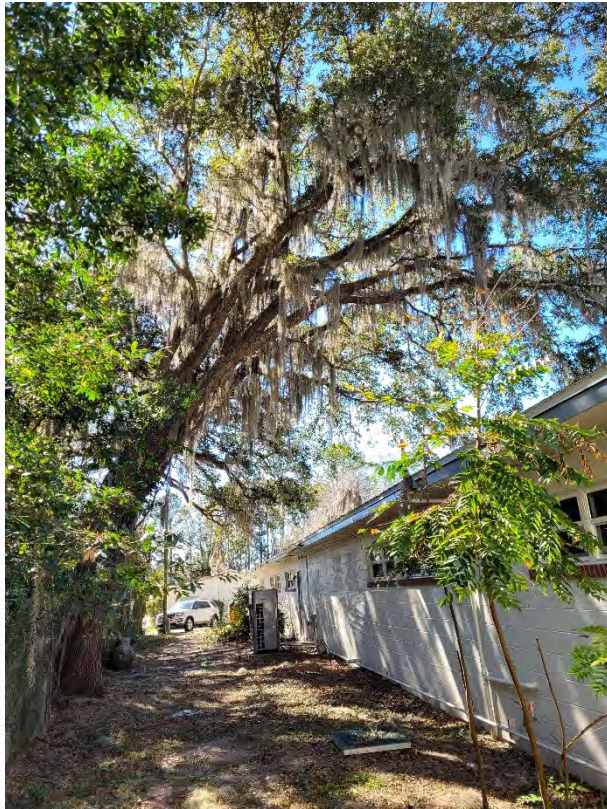
- Request removal of Live Oak leaning over B0339.
- Per picture, chainlink fence growing into base of tree.
- The tree is leaning over a building that was recently renovated at approximately \$500,000.

**Leaning Over Building**

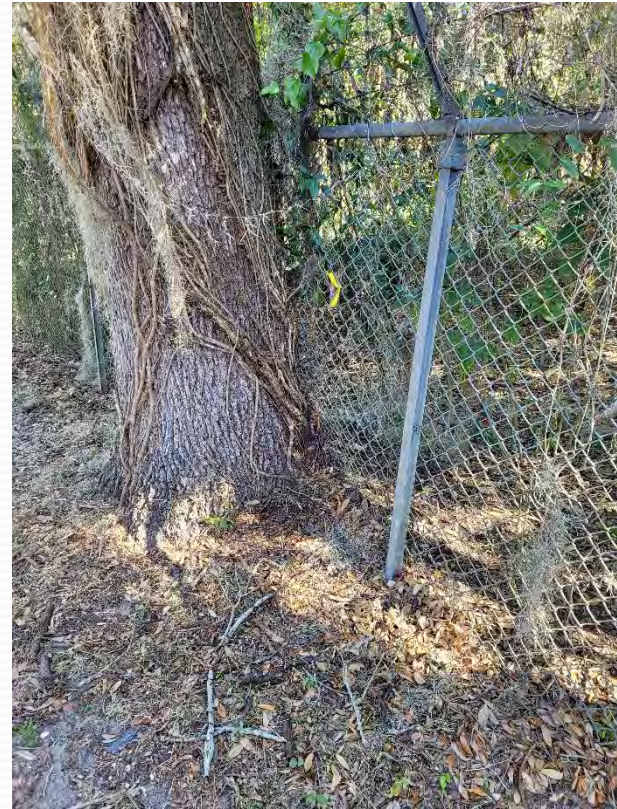
**Fencing Grown into Base**

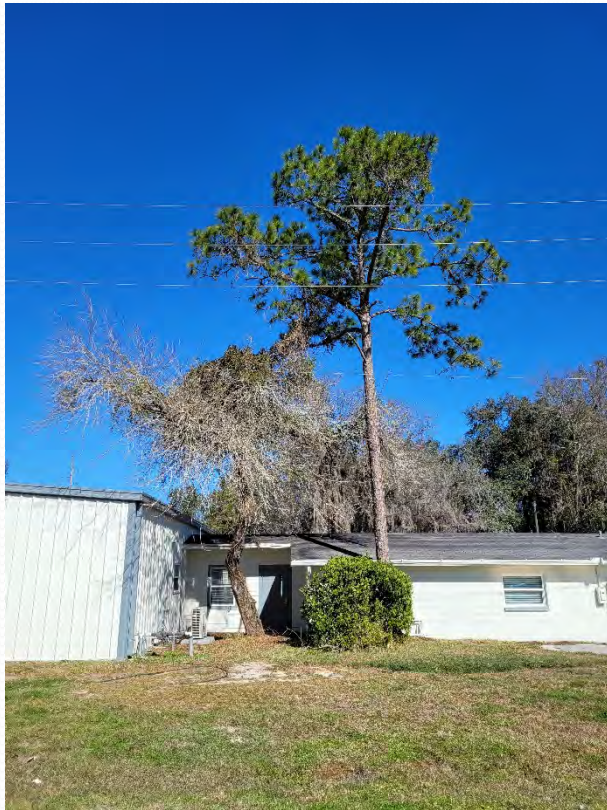
**Overall View**

- Request removal of unknown species and Loblolly Pine.
- Per picture, unknown species is nearly flat topped, overgrown with vines and unhealthy in general.
- Loblolly Pine is very close to B0350 and higher than building finish floor elevation. It is also connected to the unknown species by vine growth.
- We are working a grading project for this site to improve flow of water away from building and to drainage ditch.

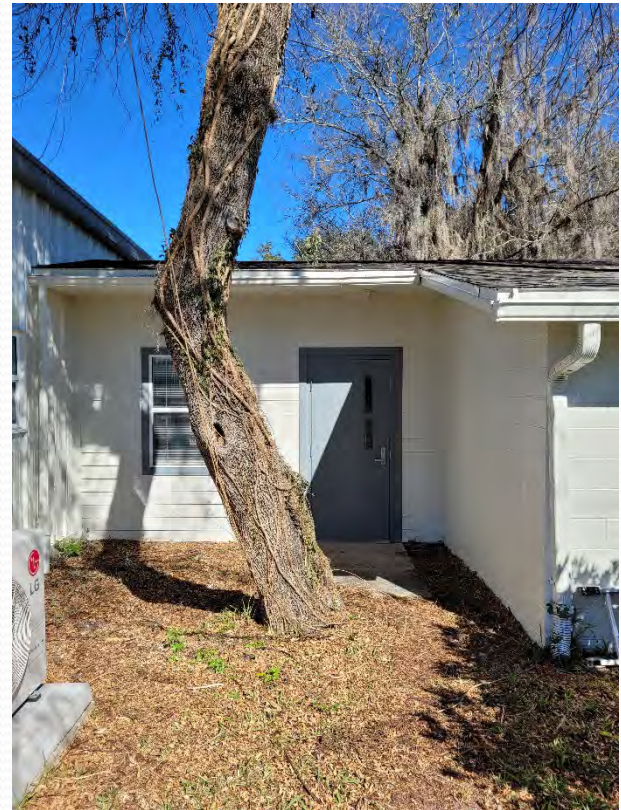
**Main Trunk and Vines**

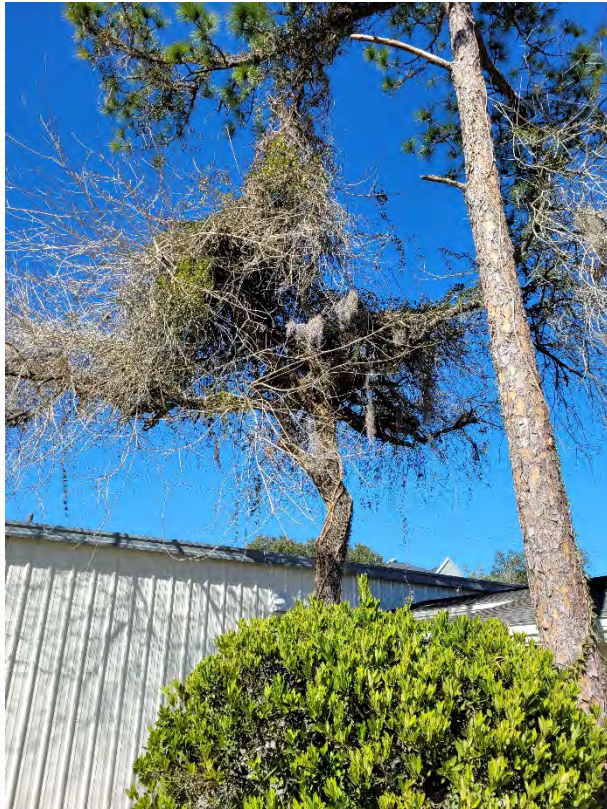
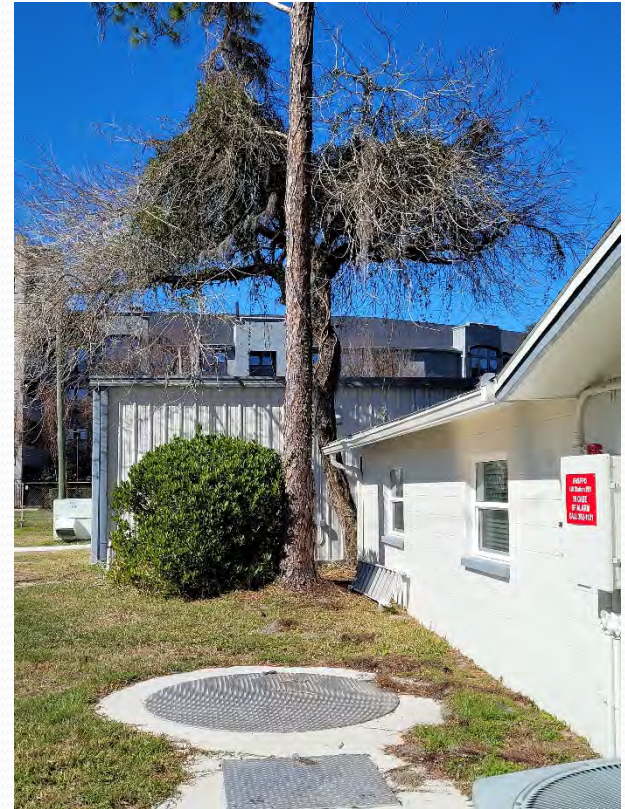
View of Growth and Health    View Looking West

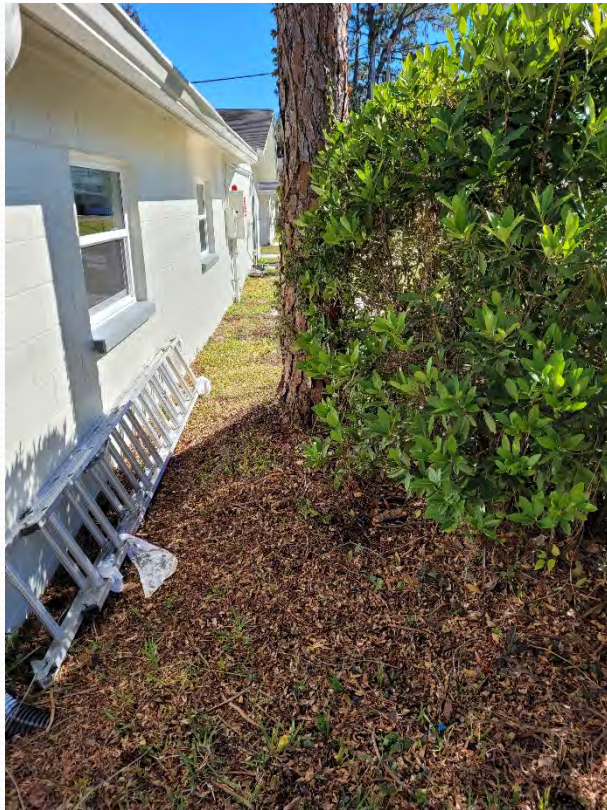
View Looking East

- IFAS Facilities is requesting removal of three trees for building maintenance reasons.
- We believe the Live Oak and Loblolly Pine pose risks to building structure; and the unknown species is in poor condition.
- Removal of the Loblolly Pine and unknown species will allow us to promote positive grading away from the building.
