Master Plan for P.K. Yonge Developmental Research School University of Florida

CONDITION ASSESSMENT BUILDING 510 (C)

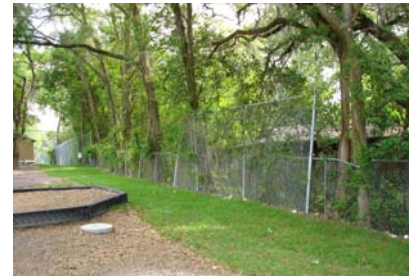
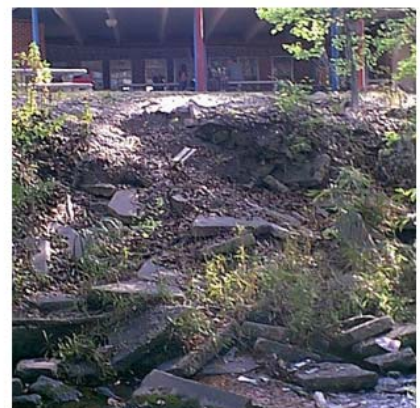
Tumblin Creek bank failure at PK Yonge Developmental School

3. Erosion – There are significant problems associated with the high flow of water through Tumblin Creek during major storm events. The water volume has eroded the banks of the creek, compromised the vegetation and threatened the adjacent structures. The lack of ground cover in many parts of the campus also contributes to sand and dirt in and around the facilities.

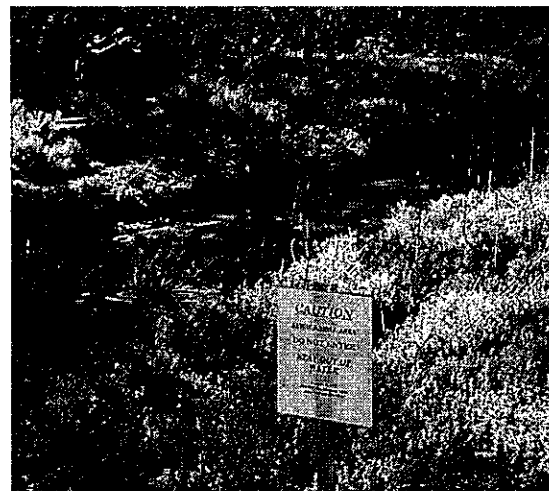
Two GRU sanitary sewer manholes were discovered leaking directly in the stream at the time the stream survey was taking place. These leaks were the result of sewage backing up through manholes due to blockages in the lines. The first one was located behind Joe's Deli on US 441 (SW 13th St.). The second was found west of US 441 along the dredged channel just upstream of the wetland. In both cases GRU was notified immediately and repairs

Sign along Tumblin Creek warning of a sewage leak

were made.

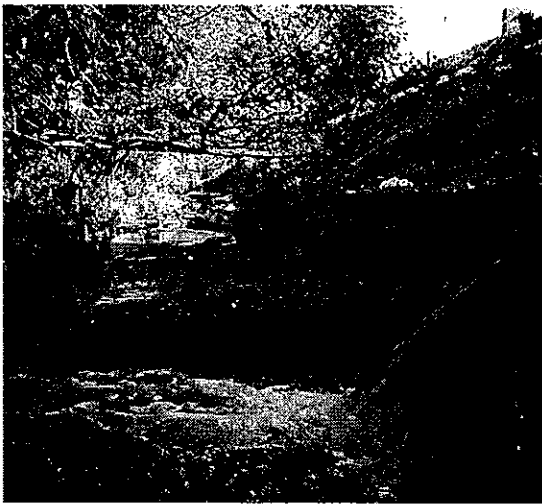
In addition, two continually flowing pipes were discovered feeding Tumblin Creek during severe drought conditions. Both were located south of SW 16th Avenue. The first discharge came from a hexagonal RCP under SW 16th Ave. The source was unknown but the water appeared to be clean. The second discharge was located on the east bank of the creek just south of Pat's Quick Stop parking lot (off of US 441/SW 13th St.). The flow from this 8-inch pipe almost doubled the flow in Tumblin Creek. Water was constantly flowing out at a high velocity. ACEPD collected a water sample and had it analyzed. The water appeared, based on quality, to be representative of water from

Continually flowing discharge into Tumblin Creek near parking lot off of SW 16th Avenue

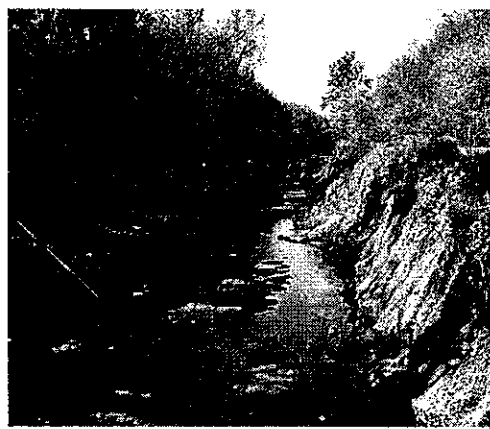
Sediment washed away from the streambed and banks during storm events turns the water gray. It is questionable what the impacts are on the aquatic biota. The sediment is carried downstream and deposited in the dredged channel west of US 441 and in the forested floodplain.

Sand deposition in the dredged channel of Tumblin Creek west of US 441
