*DATE OF PHB&S COMMITTEE MEETING*  
*DESIGN DEVELOPMENT*

# UF-689

# UF HAMILTON CENTER

# UF 689-HAMILTON CENTER

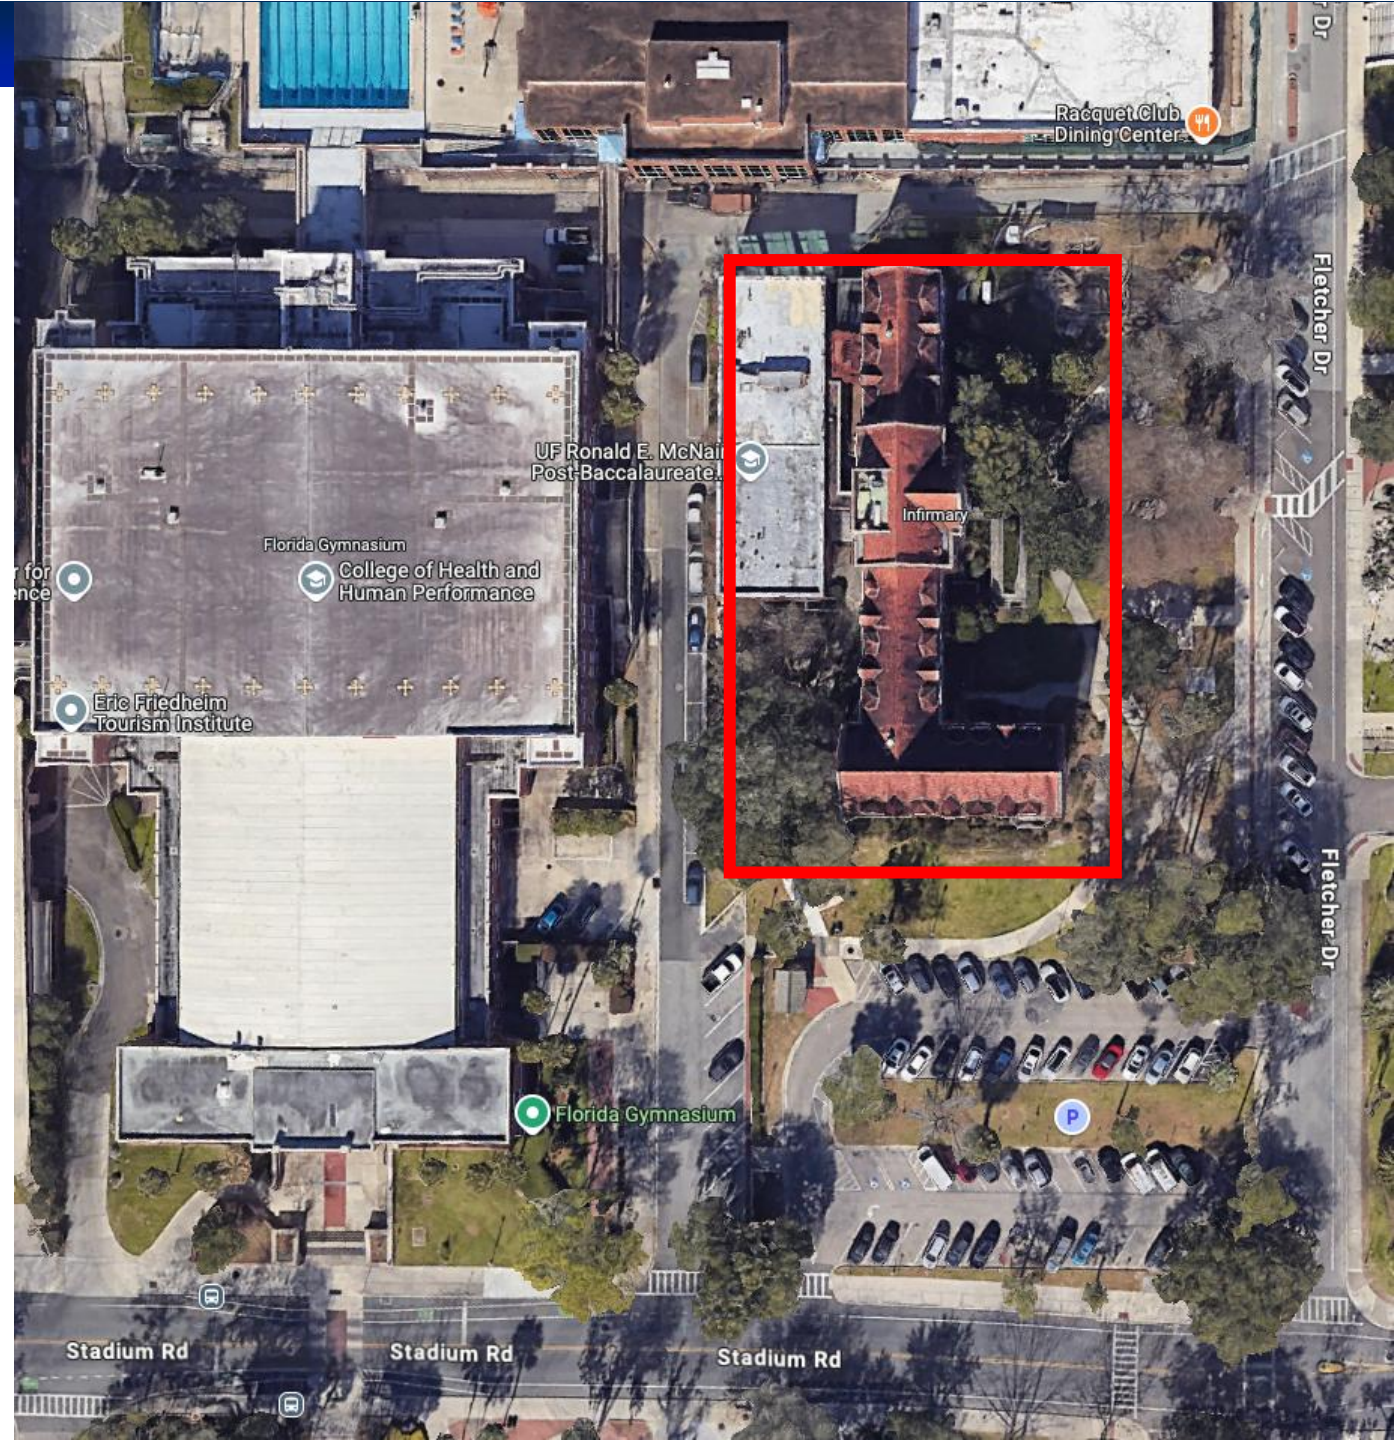
- The project is located in the West Context Zone at the intersection of Stadium Rd. and Fletcher Dr.
- The scope of this project is to replace approximately 14,000 SF and rehabilitate the existing 33,000 SF historic building
- This project seeks to renovate the exiting clinical space into a new office, classroom, and meeting/event space for the Hamilton Center

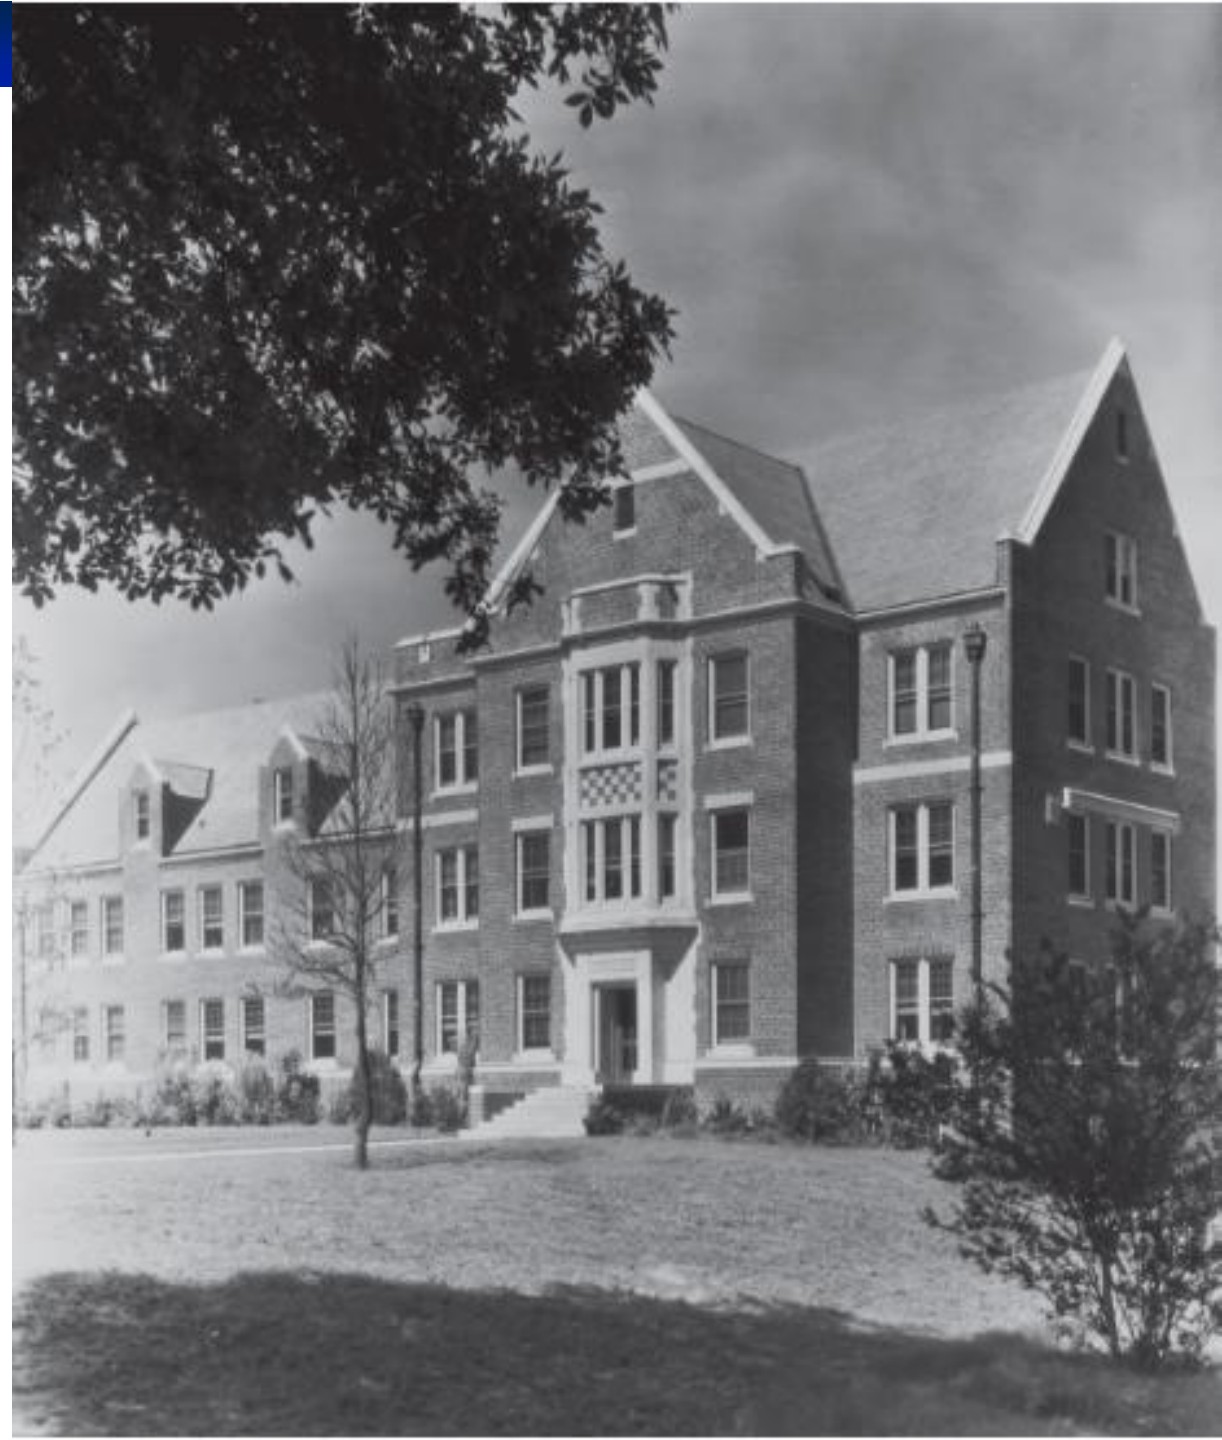
- Designed in **Collegiate Gothic style**, consistent with early UF buildings.
- Features include **symmetrical pavilions, brick masonry,** and **steep gable roofs**.
- **1931 south wing and central pavilion** are primary historic elements.
- **1947 north wing and Nurses' Home** are secondary but historically compatible.
- Maintains **high architectural integrity** and original design character.

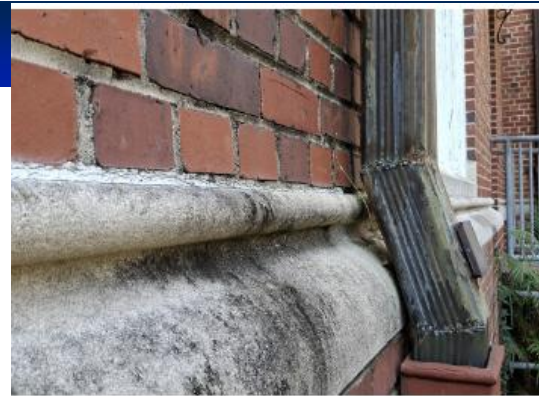
**Fig. 4.15.** Staining and some mold growth on cast elements and mortar joints. Photograph: Walker Architects, 2025.

- **Brick masonry** in good condition overall.
- Some **cracks at mortar joints** and possible **moisture intrusion** observed.
- Conditions should be **monitored and repaired** as needed.

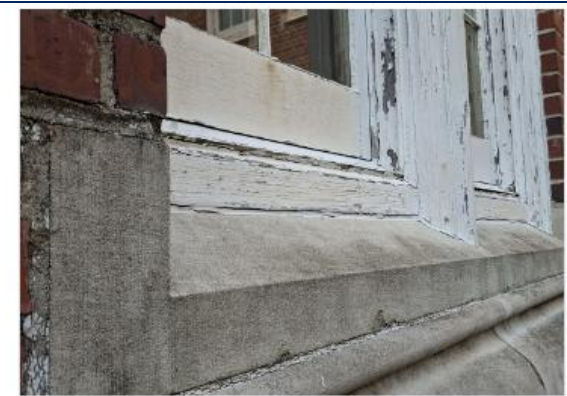
**Fig. 4.16.** Staining and some mold growth on cast elements and mortar joints. Photograph: Walker Architects, 2025.

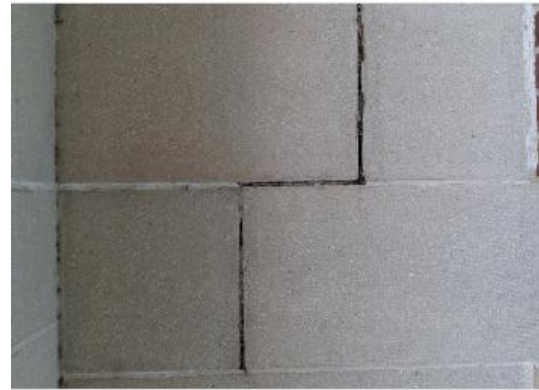
**Fig. 4.17.** Example of mortar in need of repair. Photograph: Walker Architects, 2025.

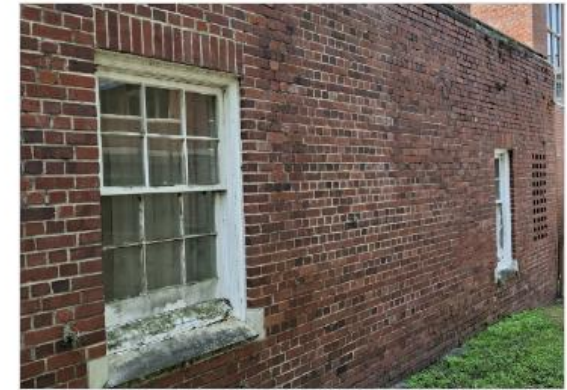
**Fig. 4.18.** Example of brick staining and mold growth. Photograph: Walker Architects, 2025.

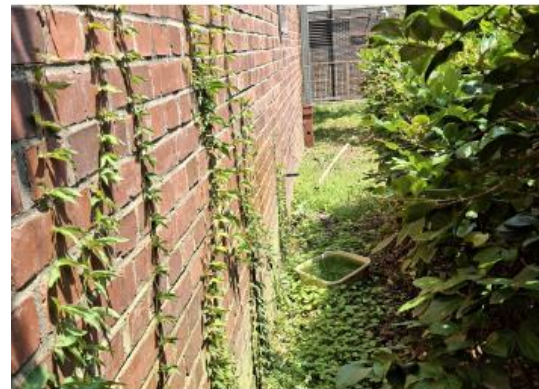
**Fig. 4.19.** Example of area in shade and/or near condensate drains with excessive plant growth. Photograph: Walker Architects, 2025.

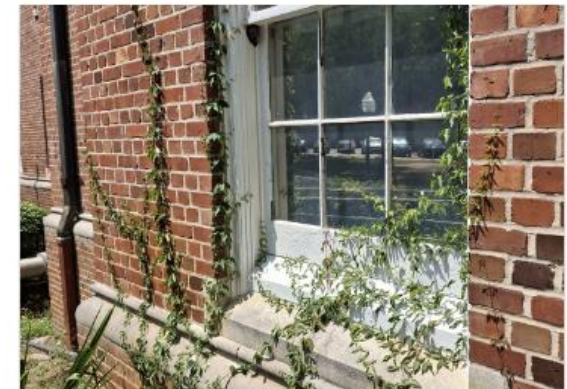
**Fig. 4.20.** Example of area in shade and/or near condensate drains with excessive plant growth. Photograph: Walker Architects, 2025.

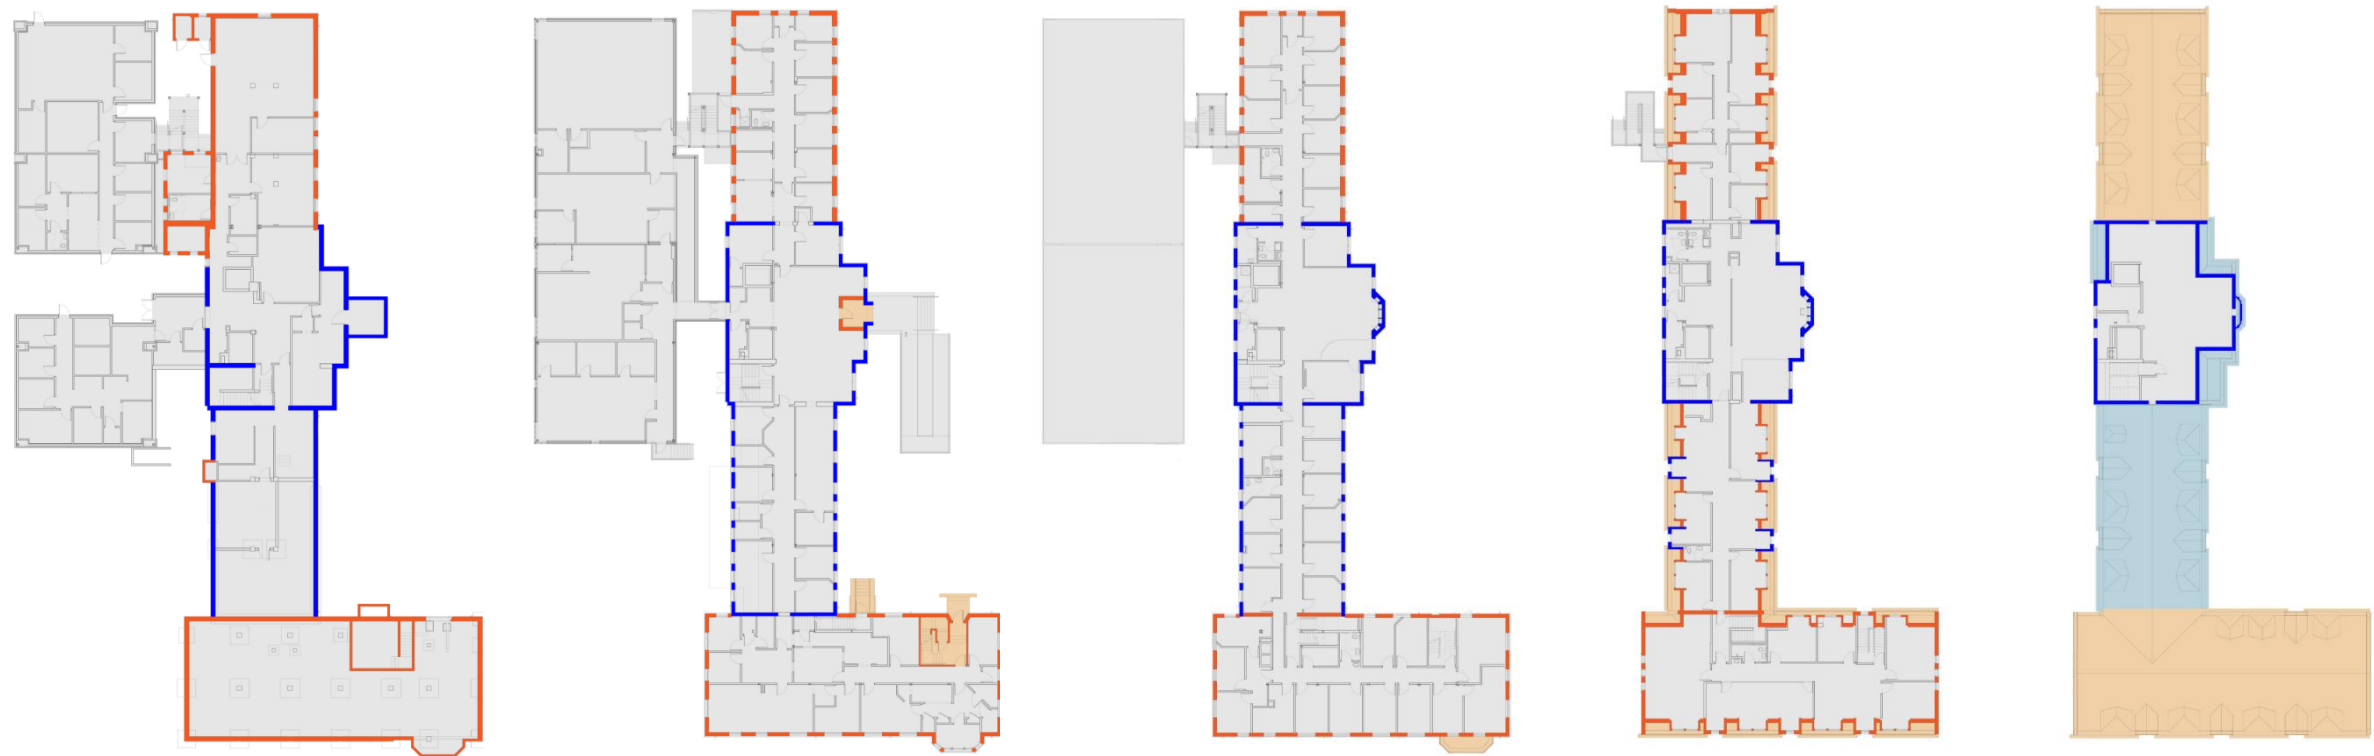
- **Primary significance:** Original 1931 pavilion and south wing facades, retaining key historic features.
- **Secondary significance:** 1947 additions (north wing, Nurses' Home), certain original interior elements like the main stair.
- **No significance:** 1975 and later renovations with no remaining historic features.
- **Undesignated:** Inaccessible areas pending further assessment.

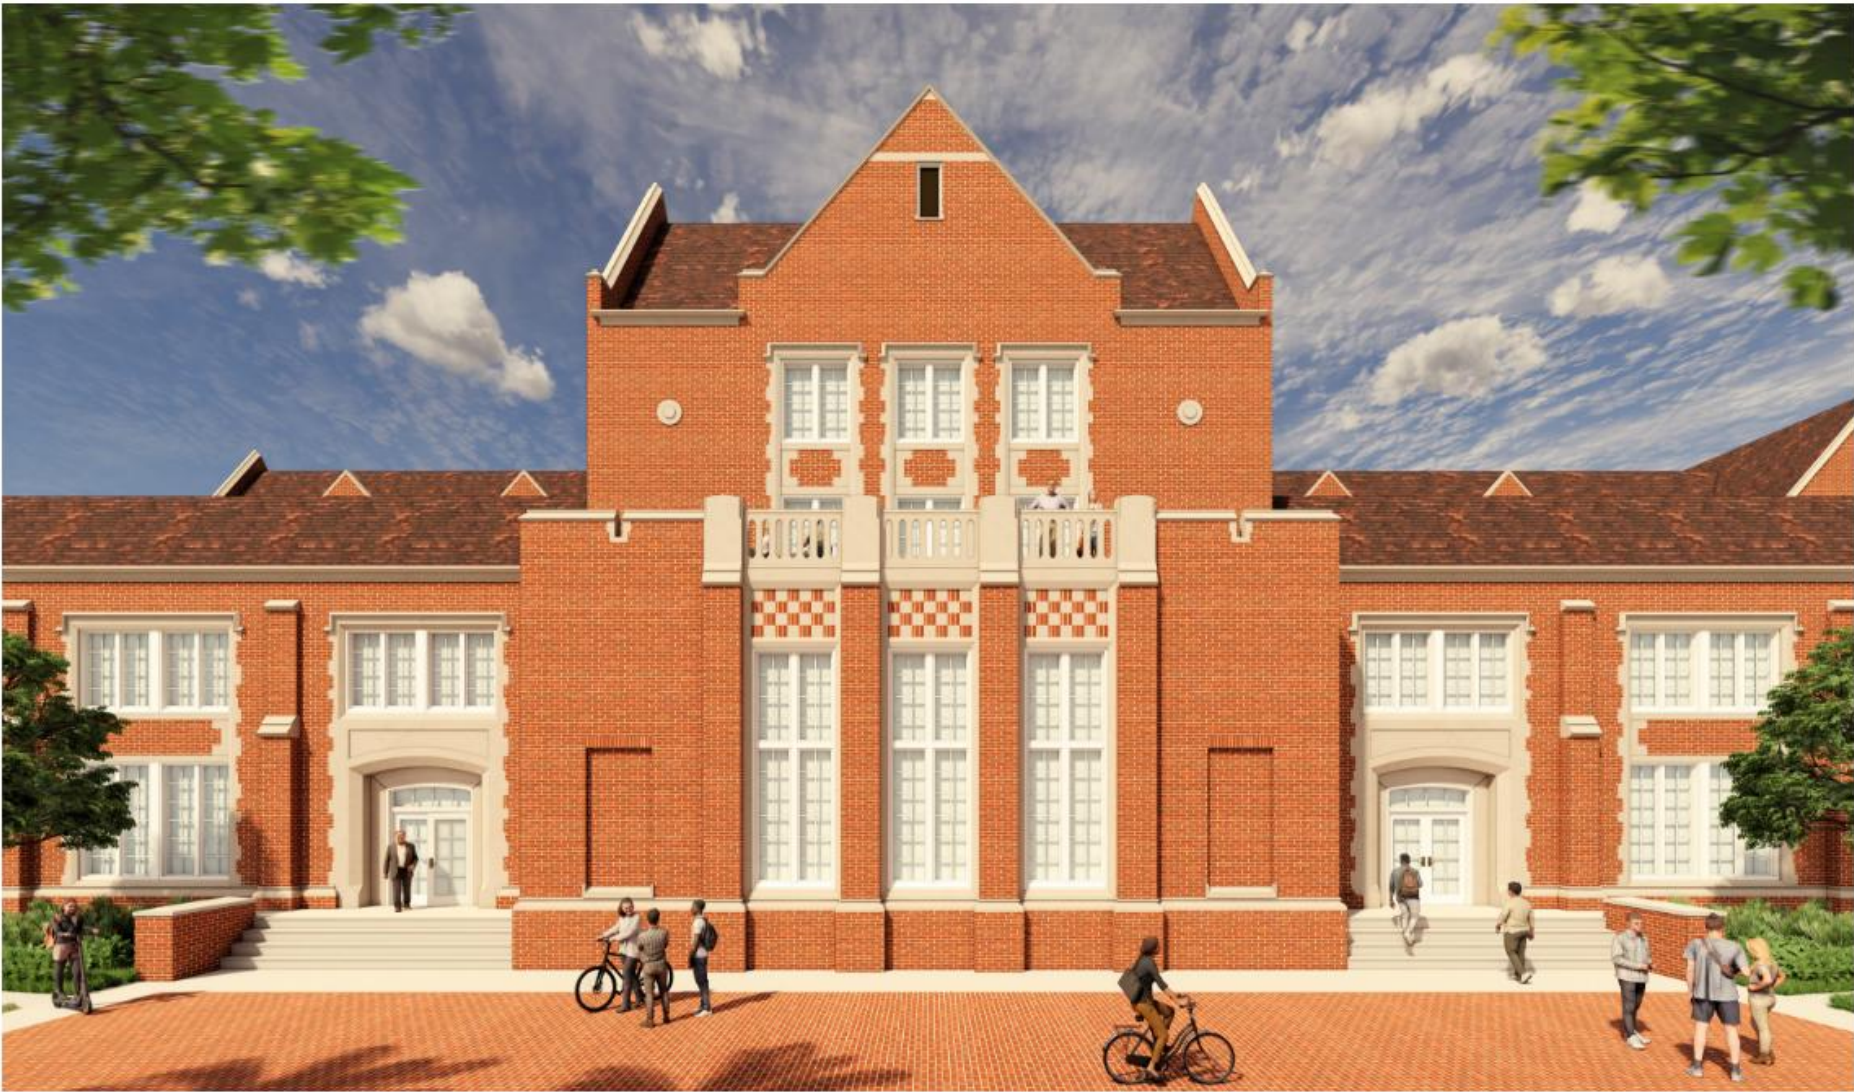
The west entry is designed in the Collegiate Gothic style to relate to the surrounding campus architecture. Its use of brick detailing, stone accents, and vertical emphasis creates a strong visual connection to adjacent historic buildings while clearly identifying the entrance as a thoughtfully integrated design move.
