UF-200
New Public Safety Building
Programing Phase
Lakes, Vegetation and Landscaping
Committee

UF 200 - New Public Safety Building

UF-645

Shealy Drive Parking Deck

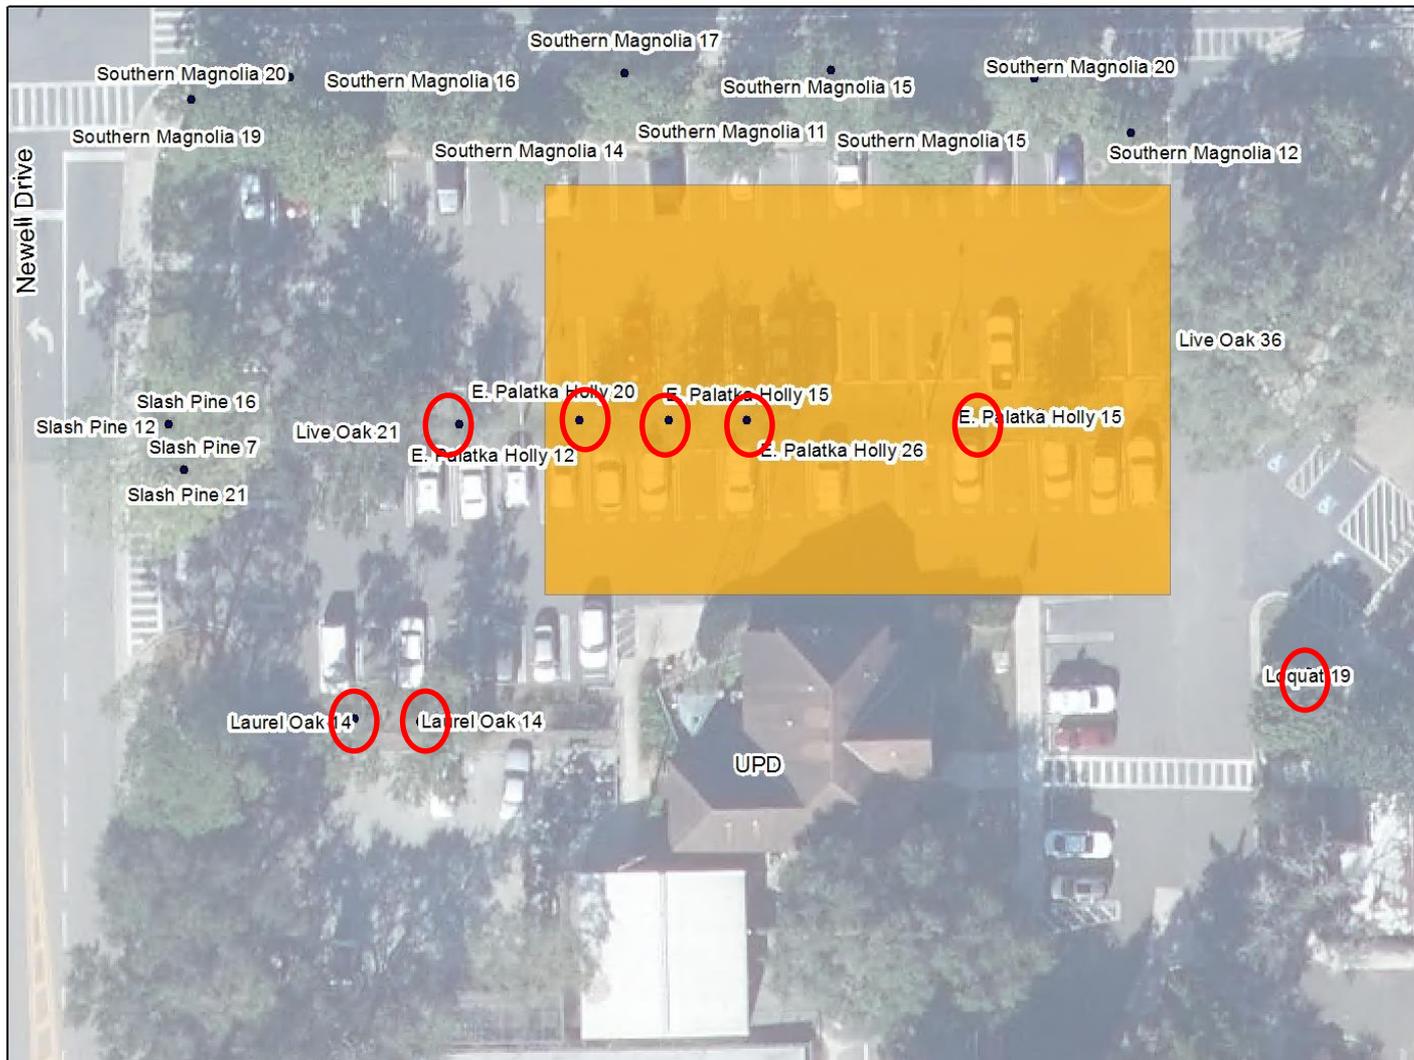
Eight (8) Existing Tree to be removed on the Proposed Site for UF 200 - New Public Safety Building

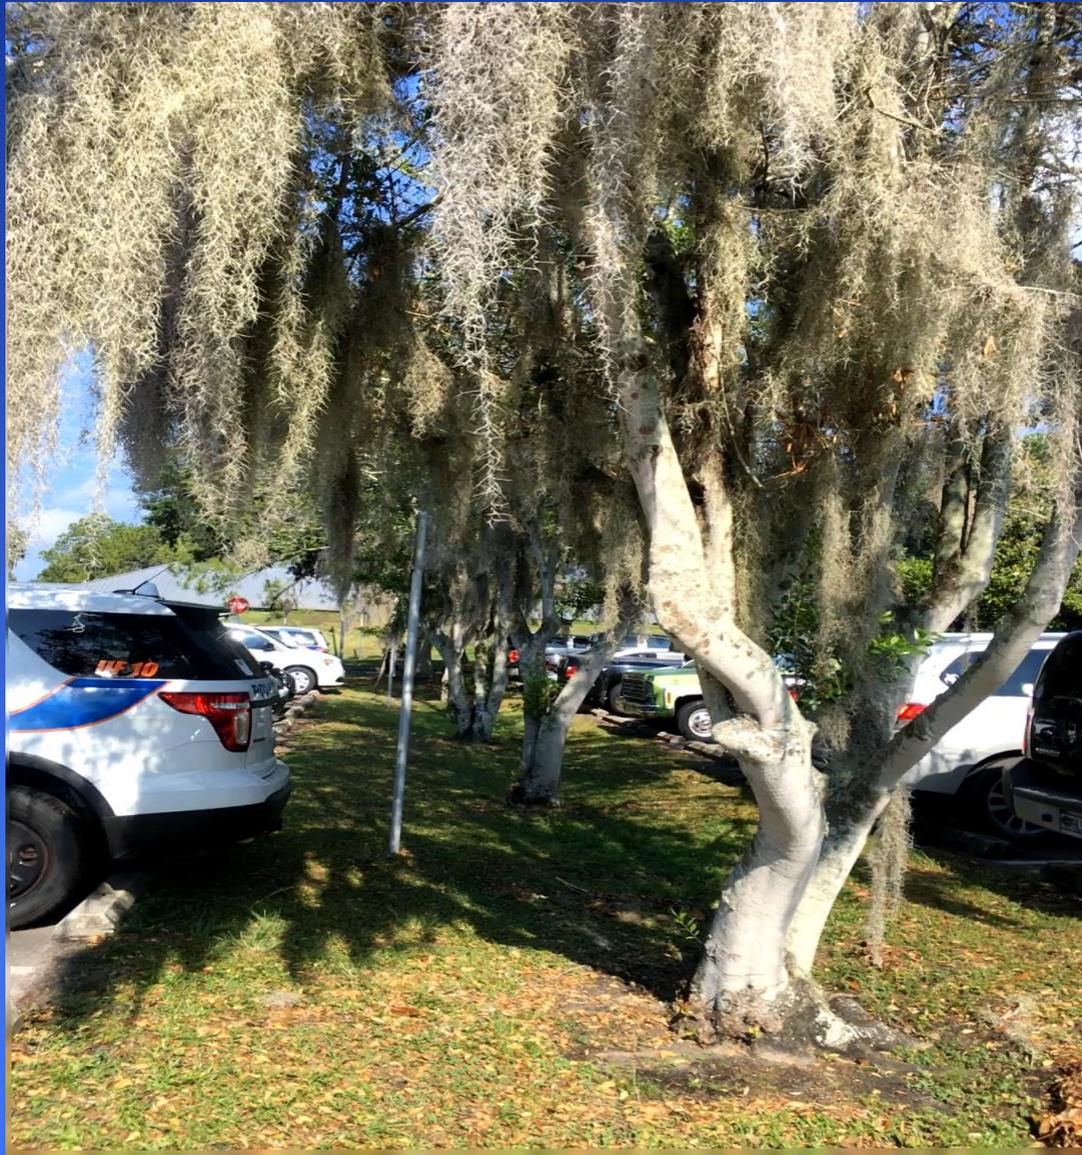
Five (5) E.
Palatka Holly
Trees to be
removed

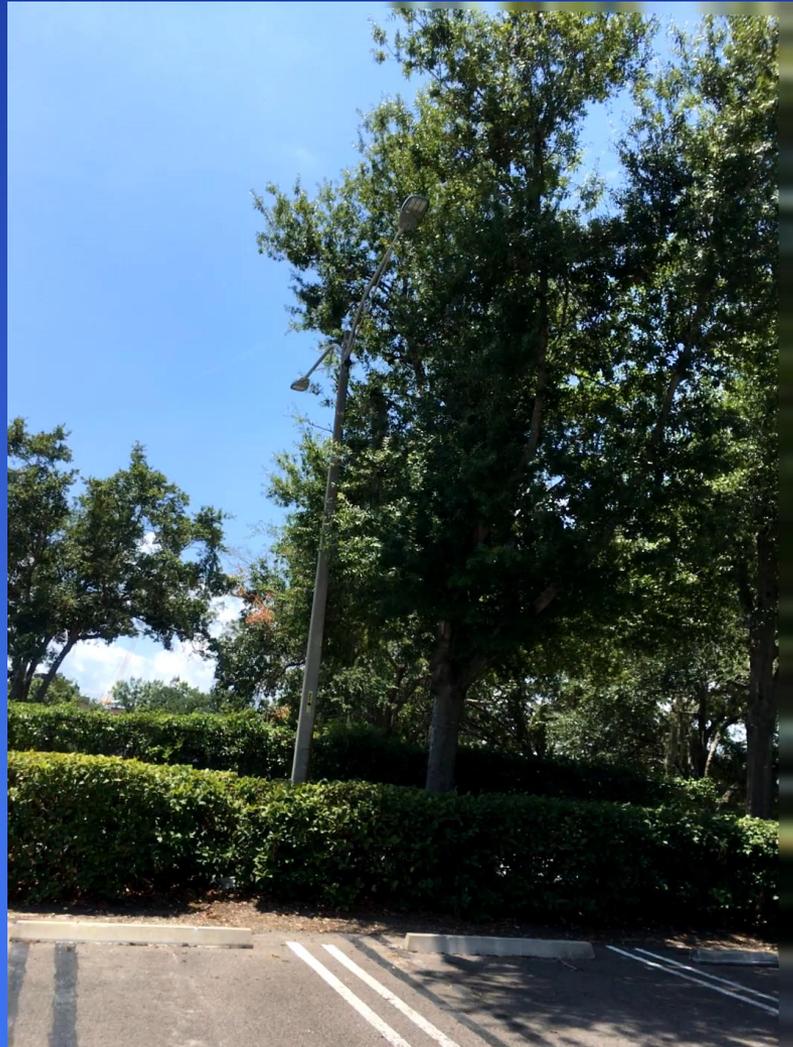
Two (2) laurel
Oak Trees to
be removed

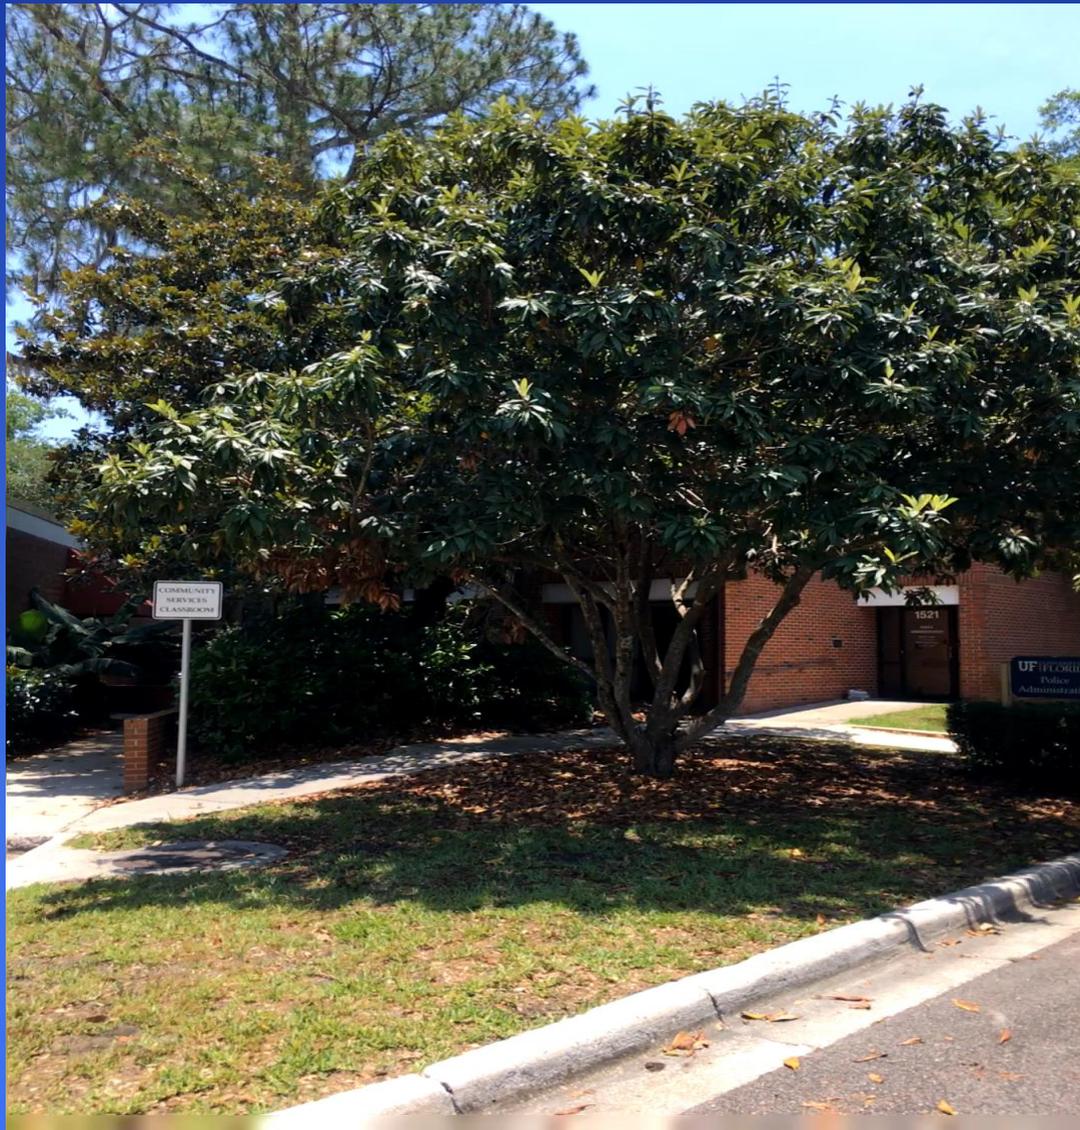
One (1)
Loquat Tree to
be removed

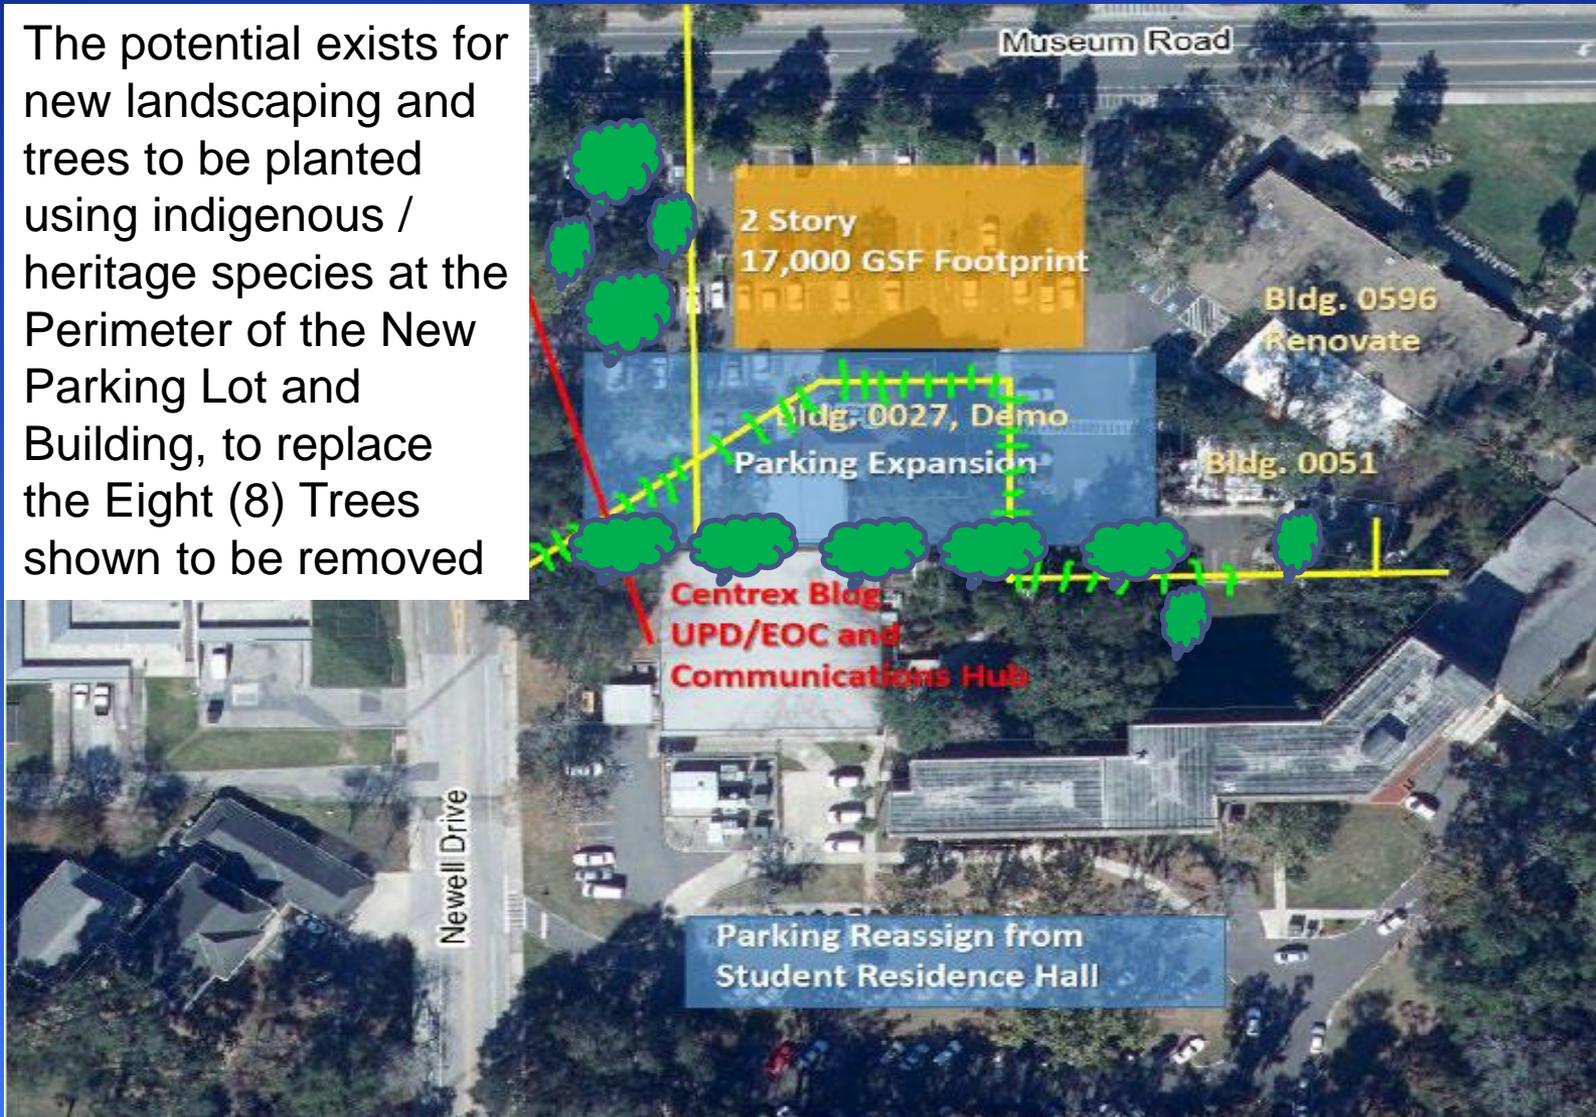
Future Landscape Restoration for UF 200 - New Public Safety Building

The potential exists for new landscaping and trees to be planted using indigenous / heritage species at the Perimeter of the New Parking Lot and Building, to replace the Eight (8) Trees shown to be removed

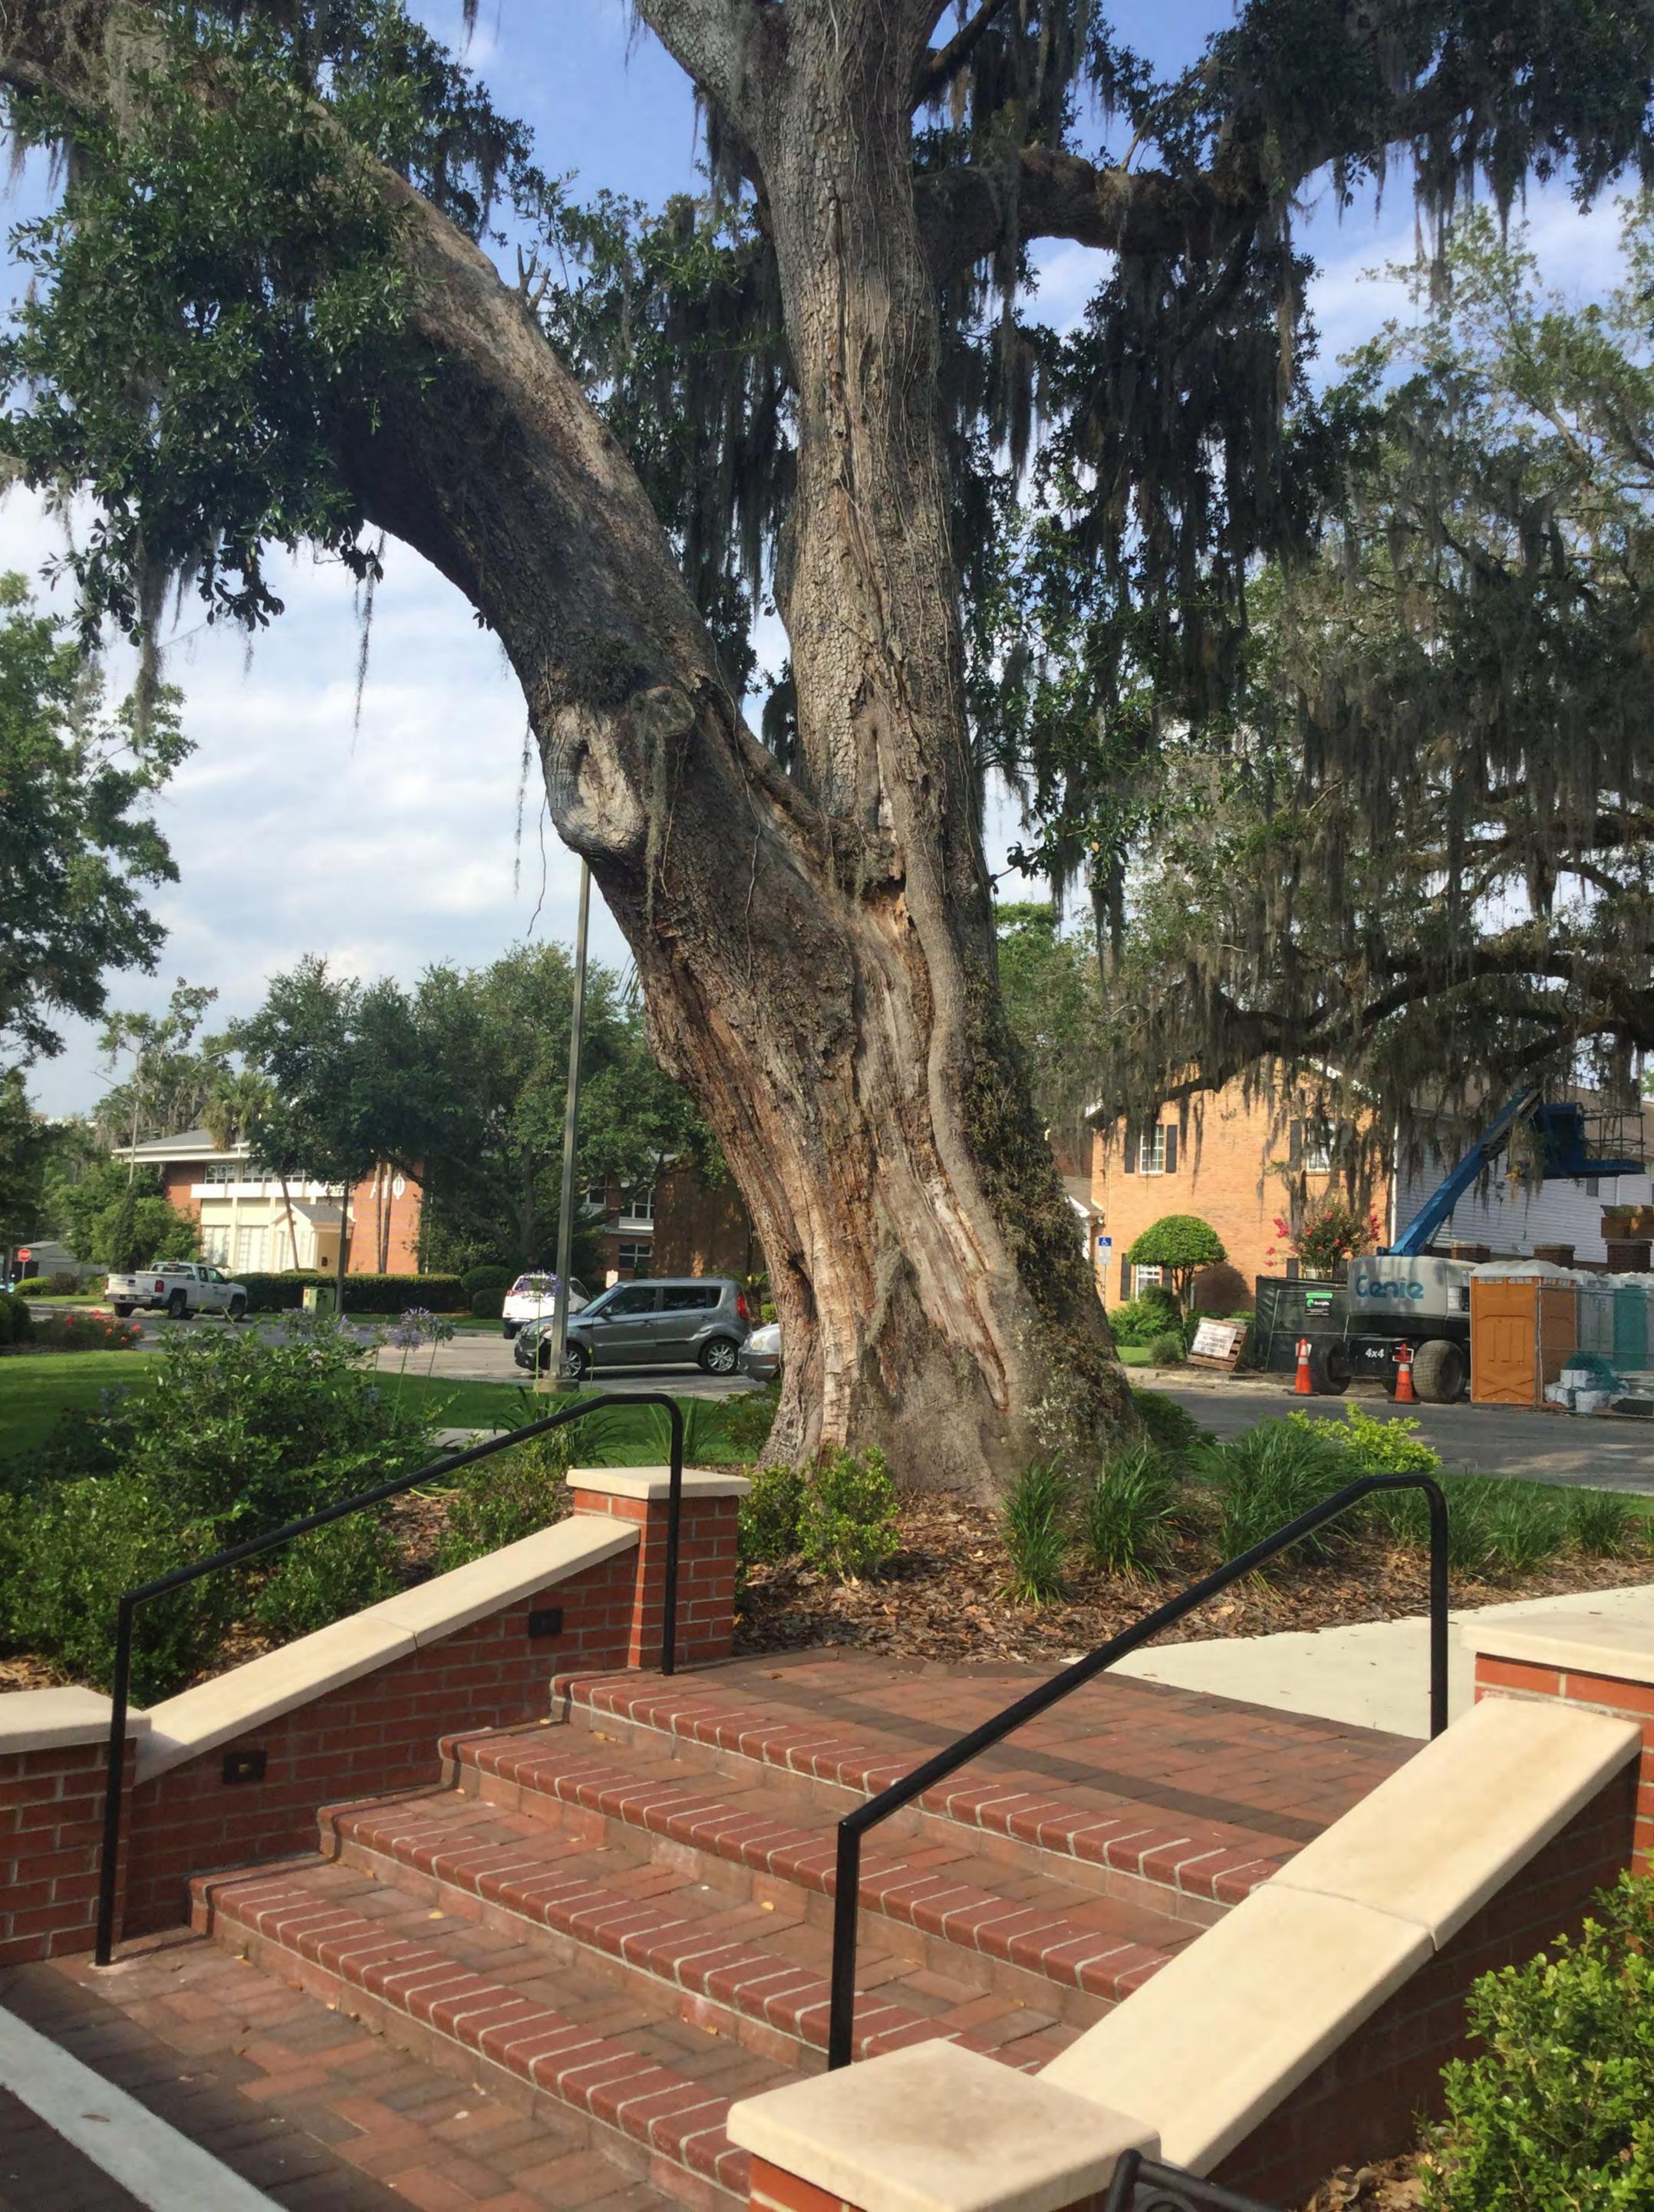
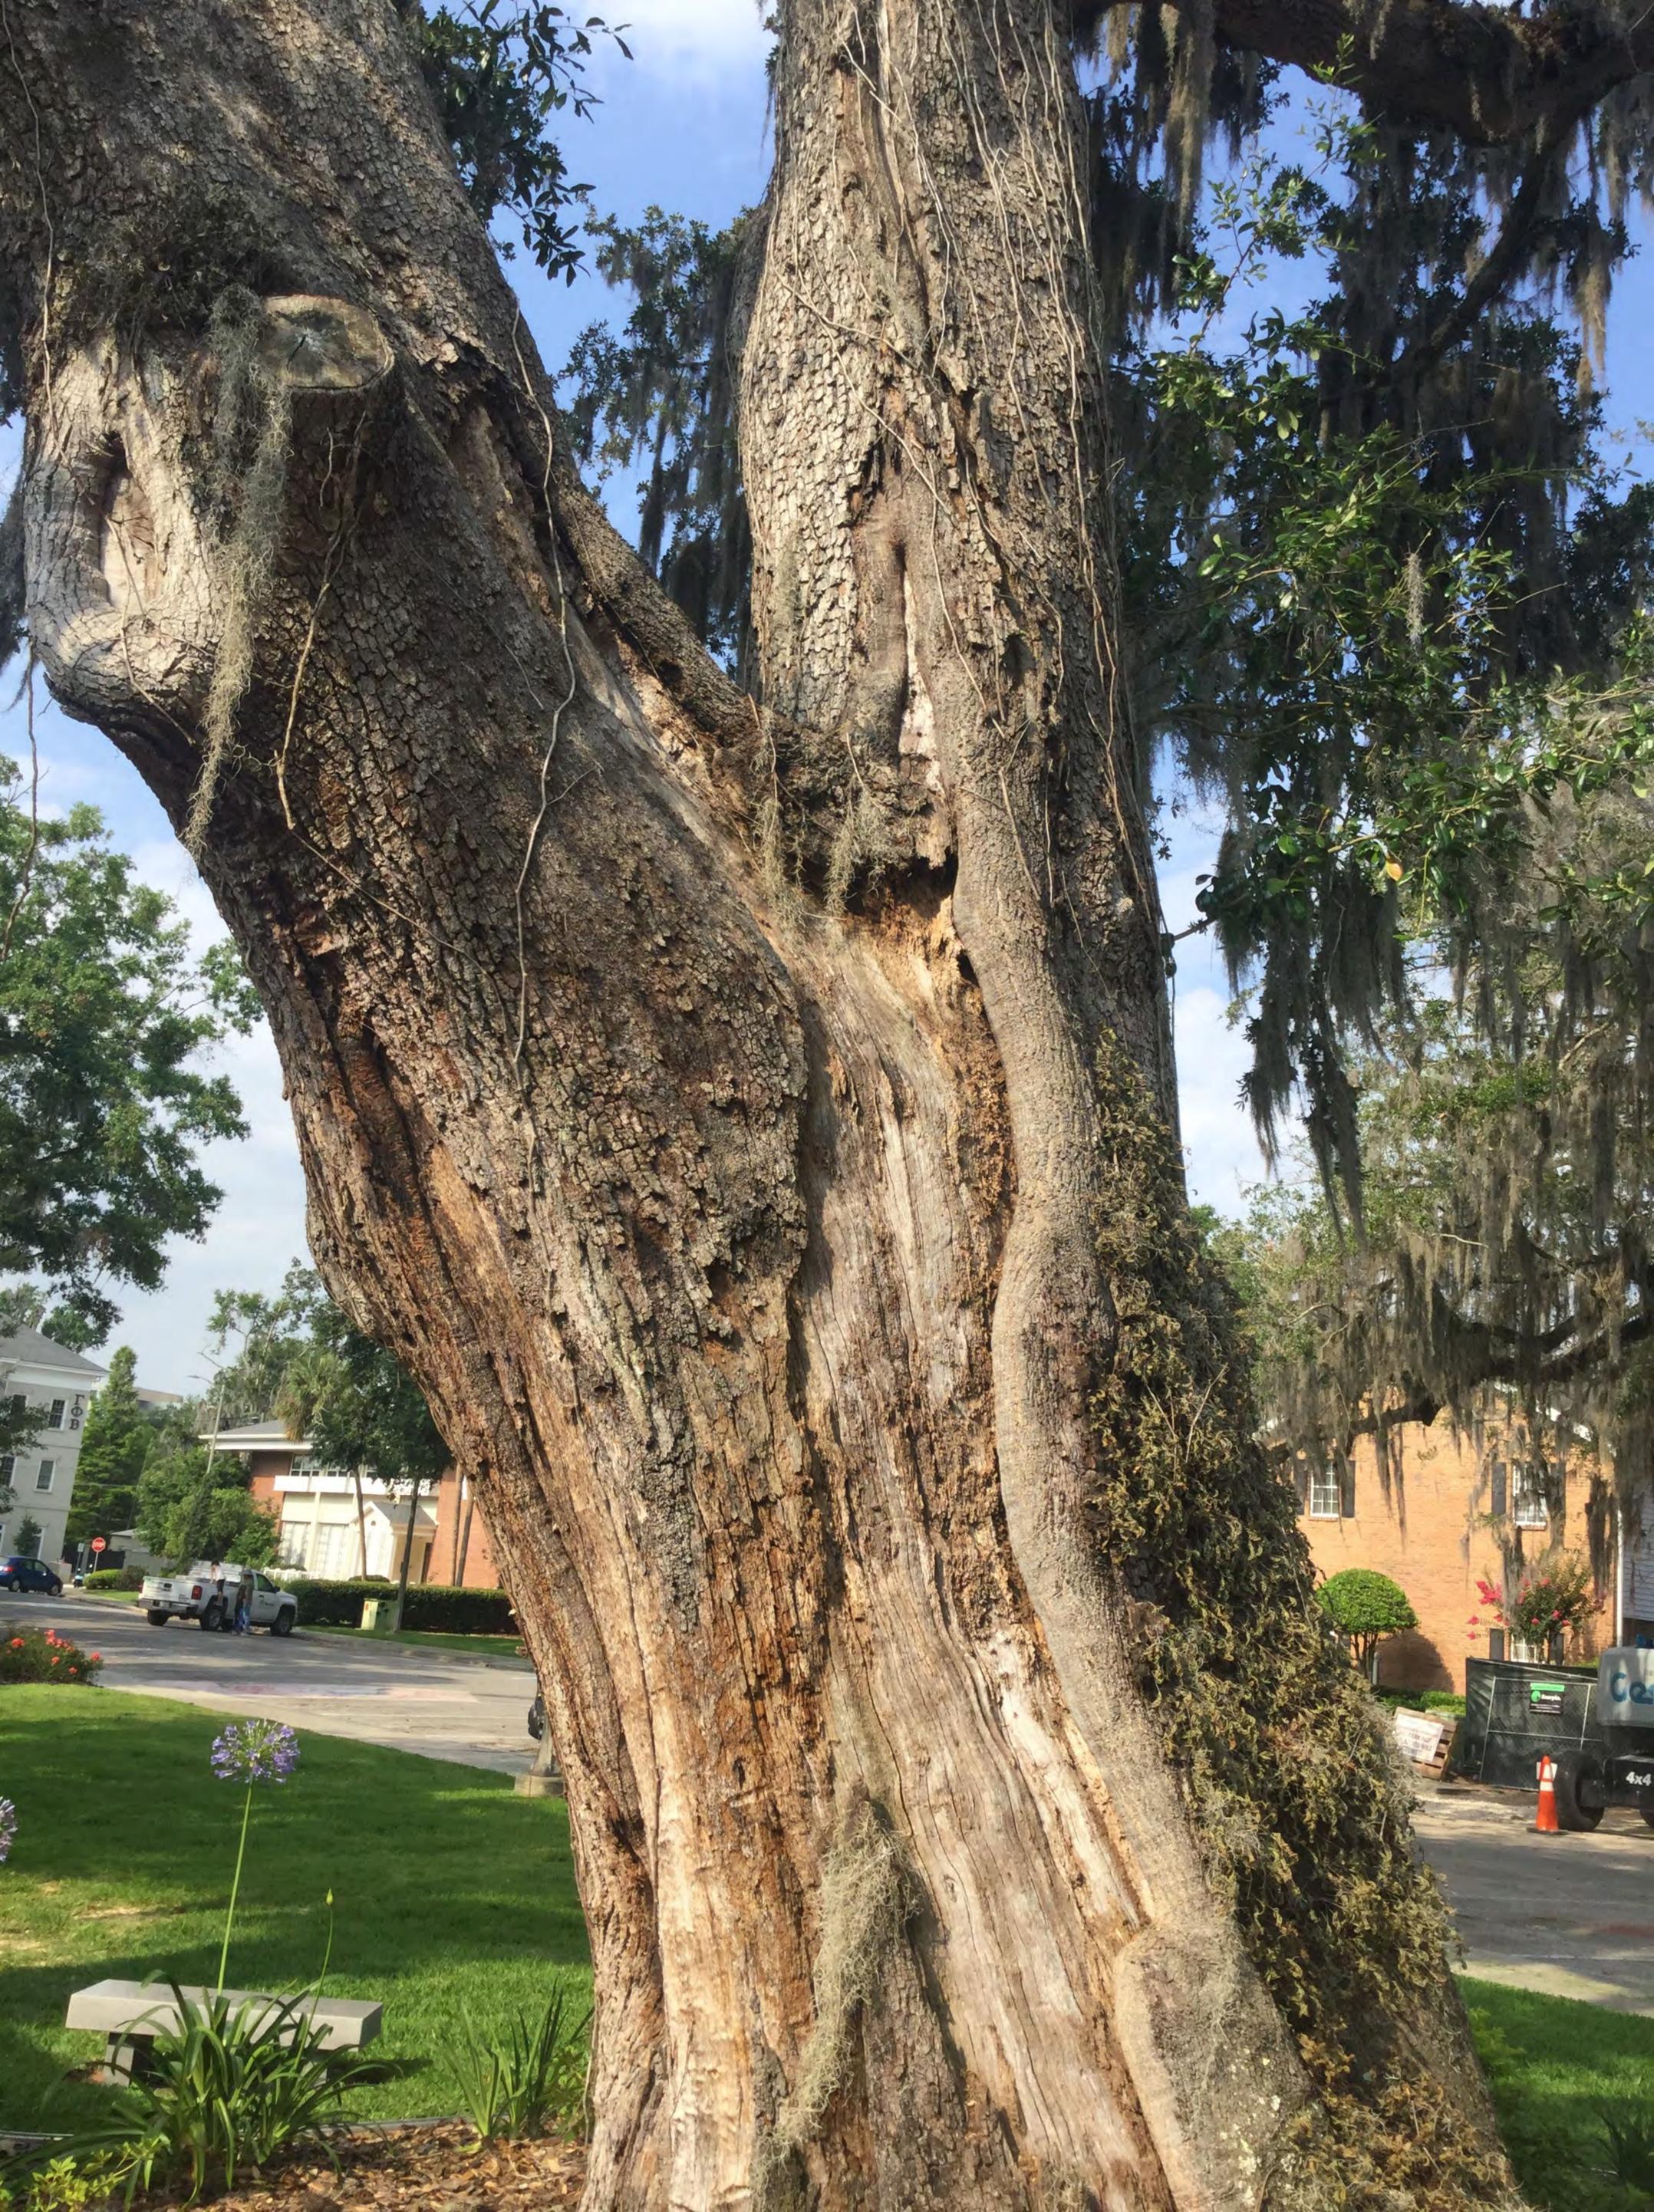
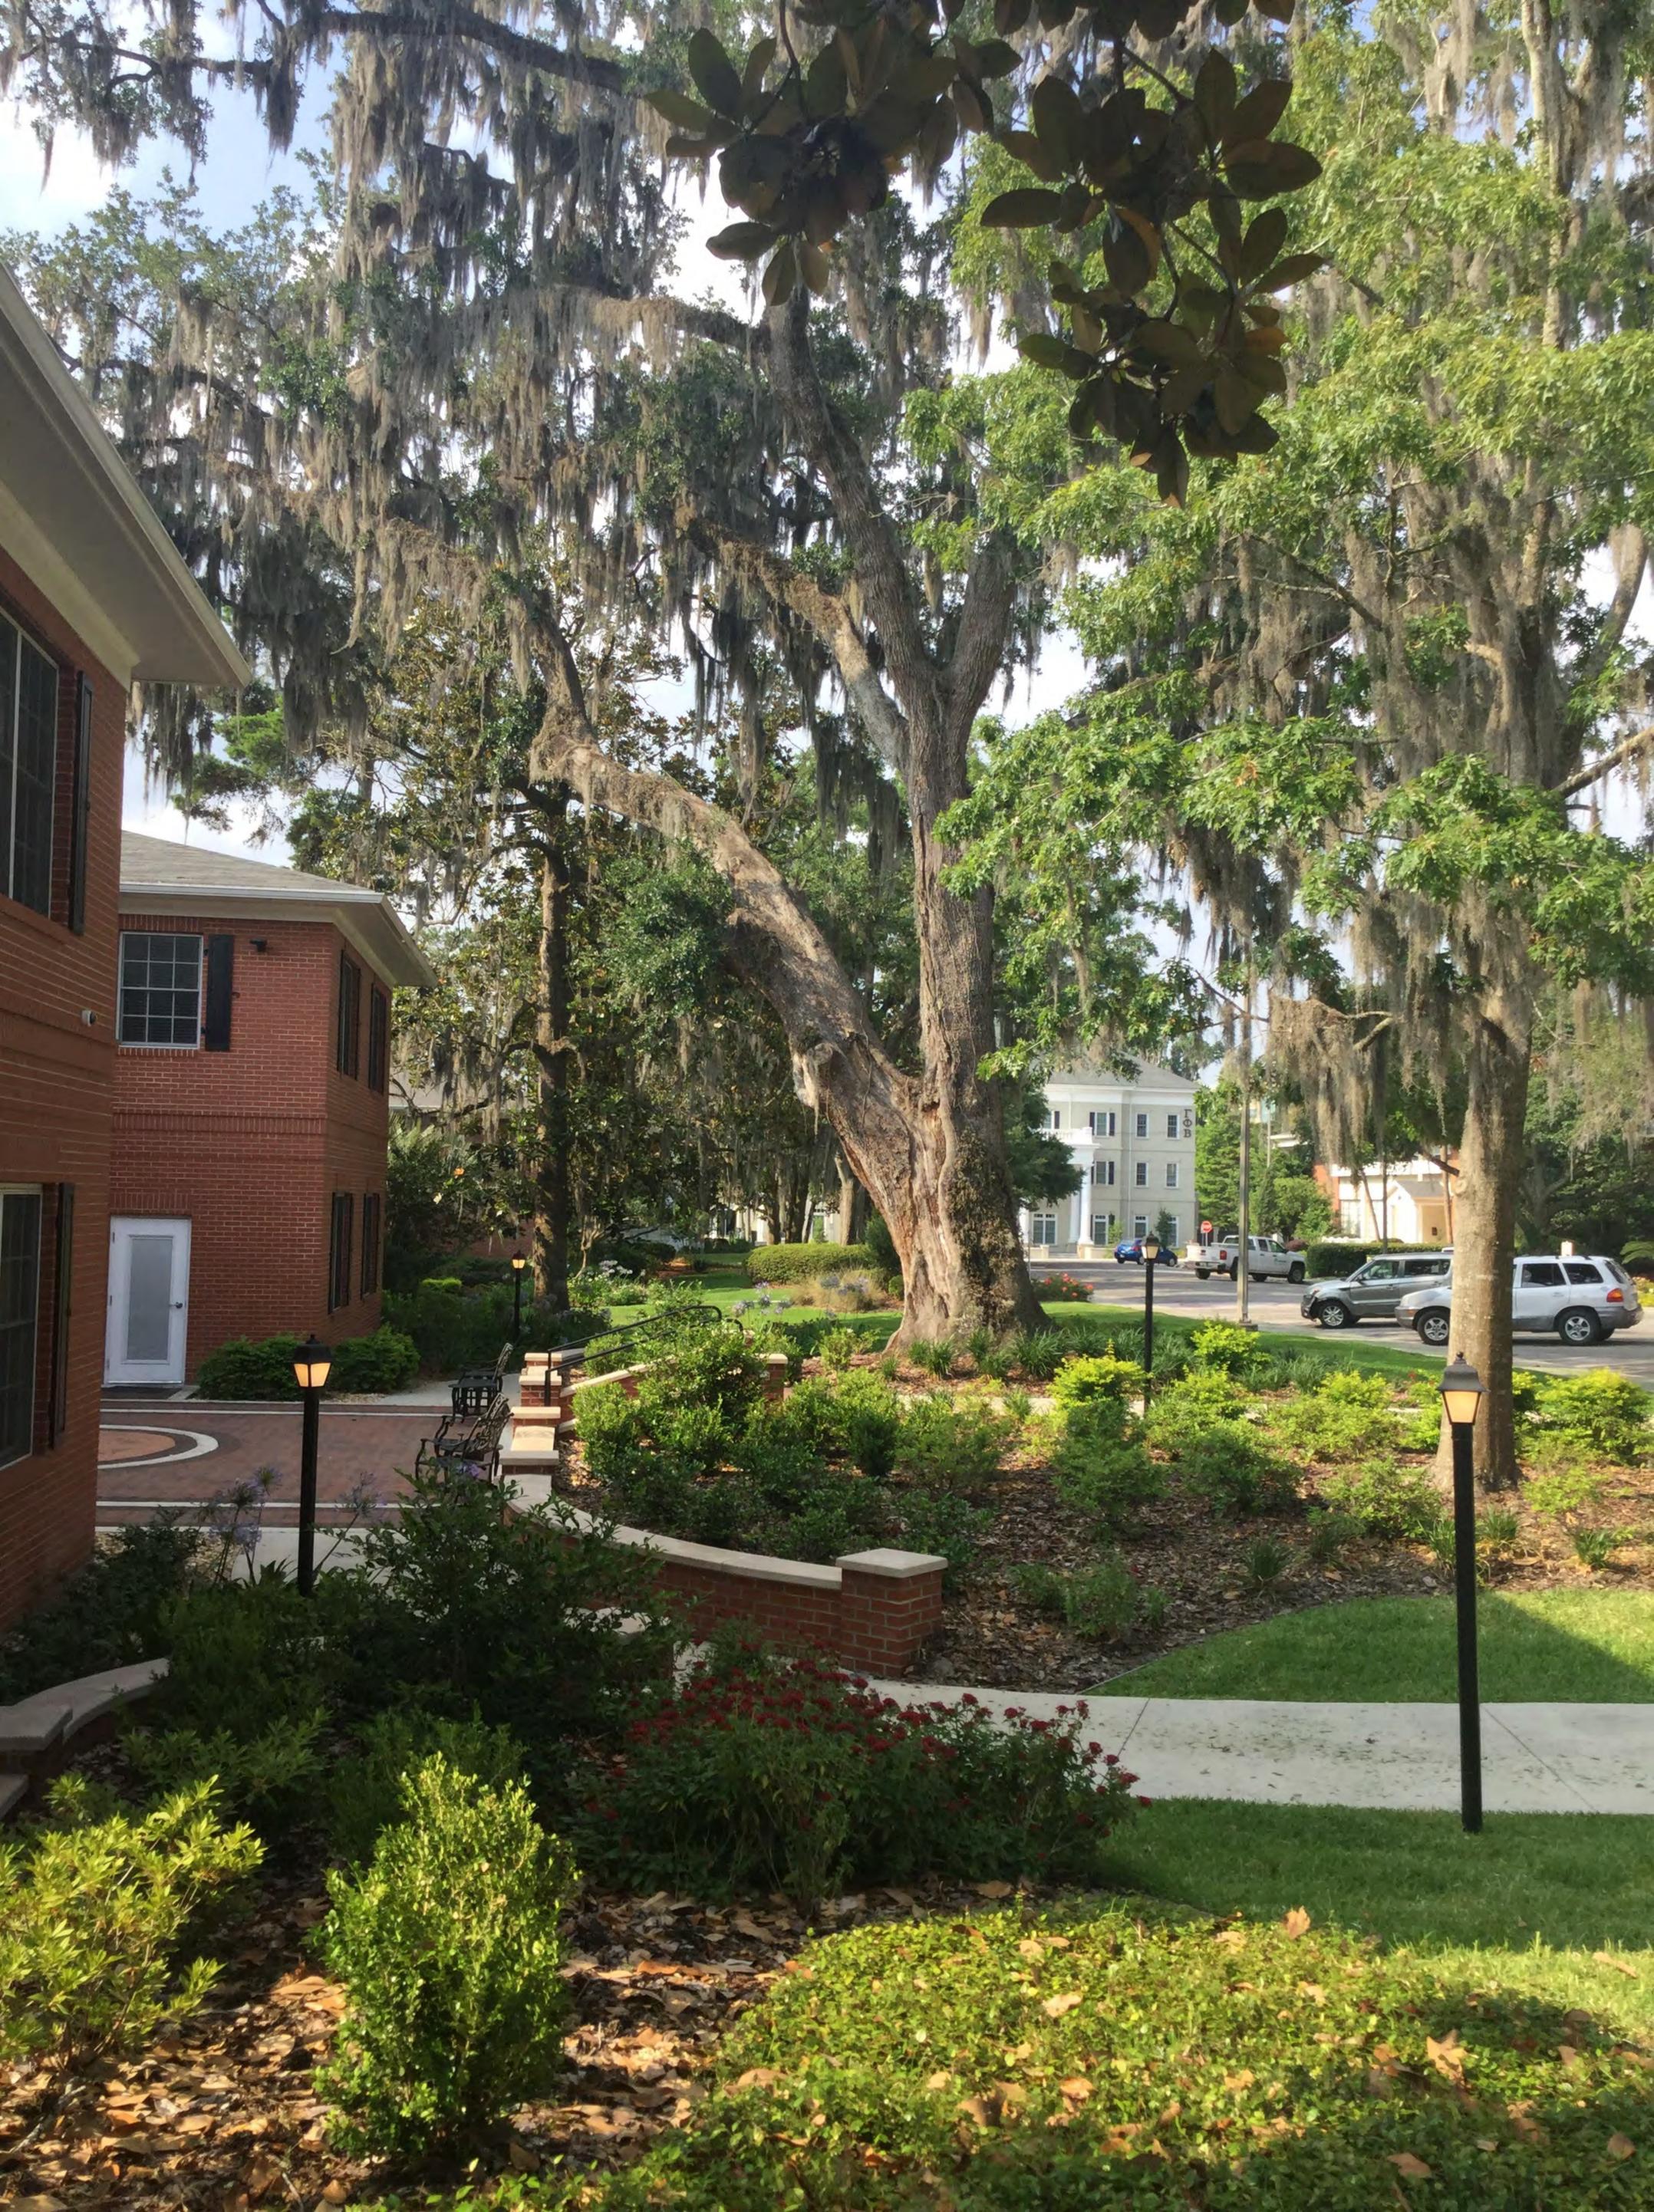
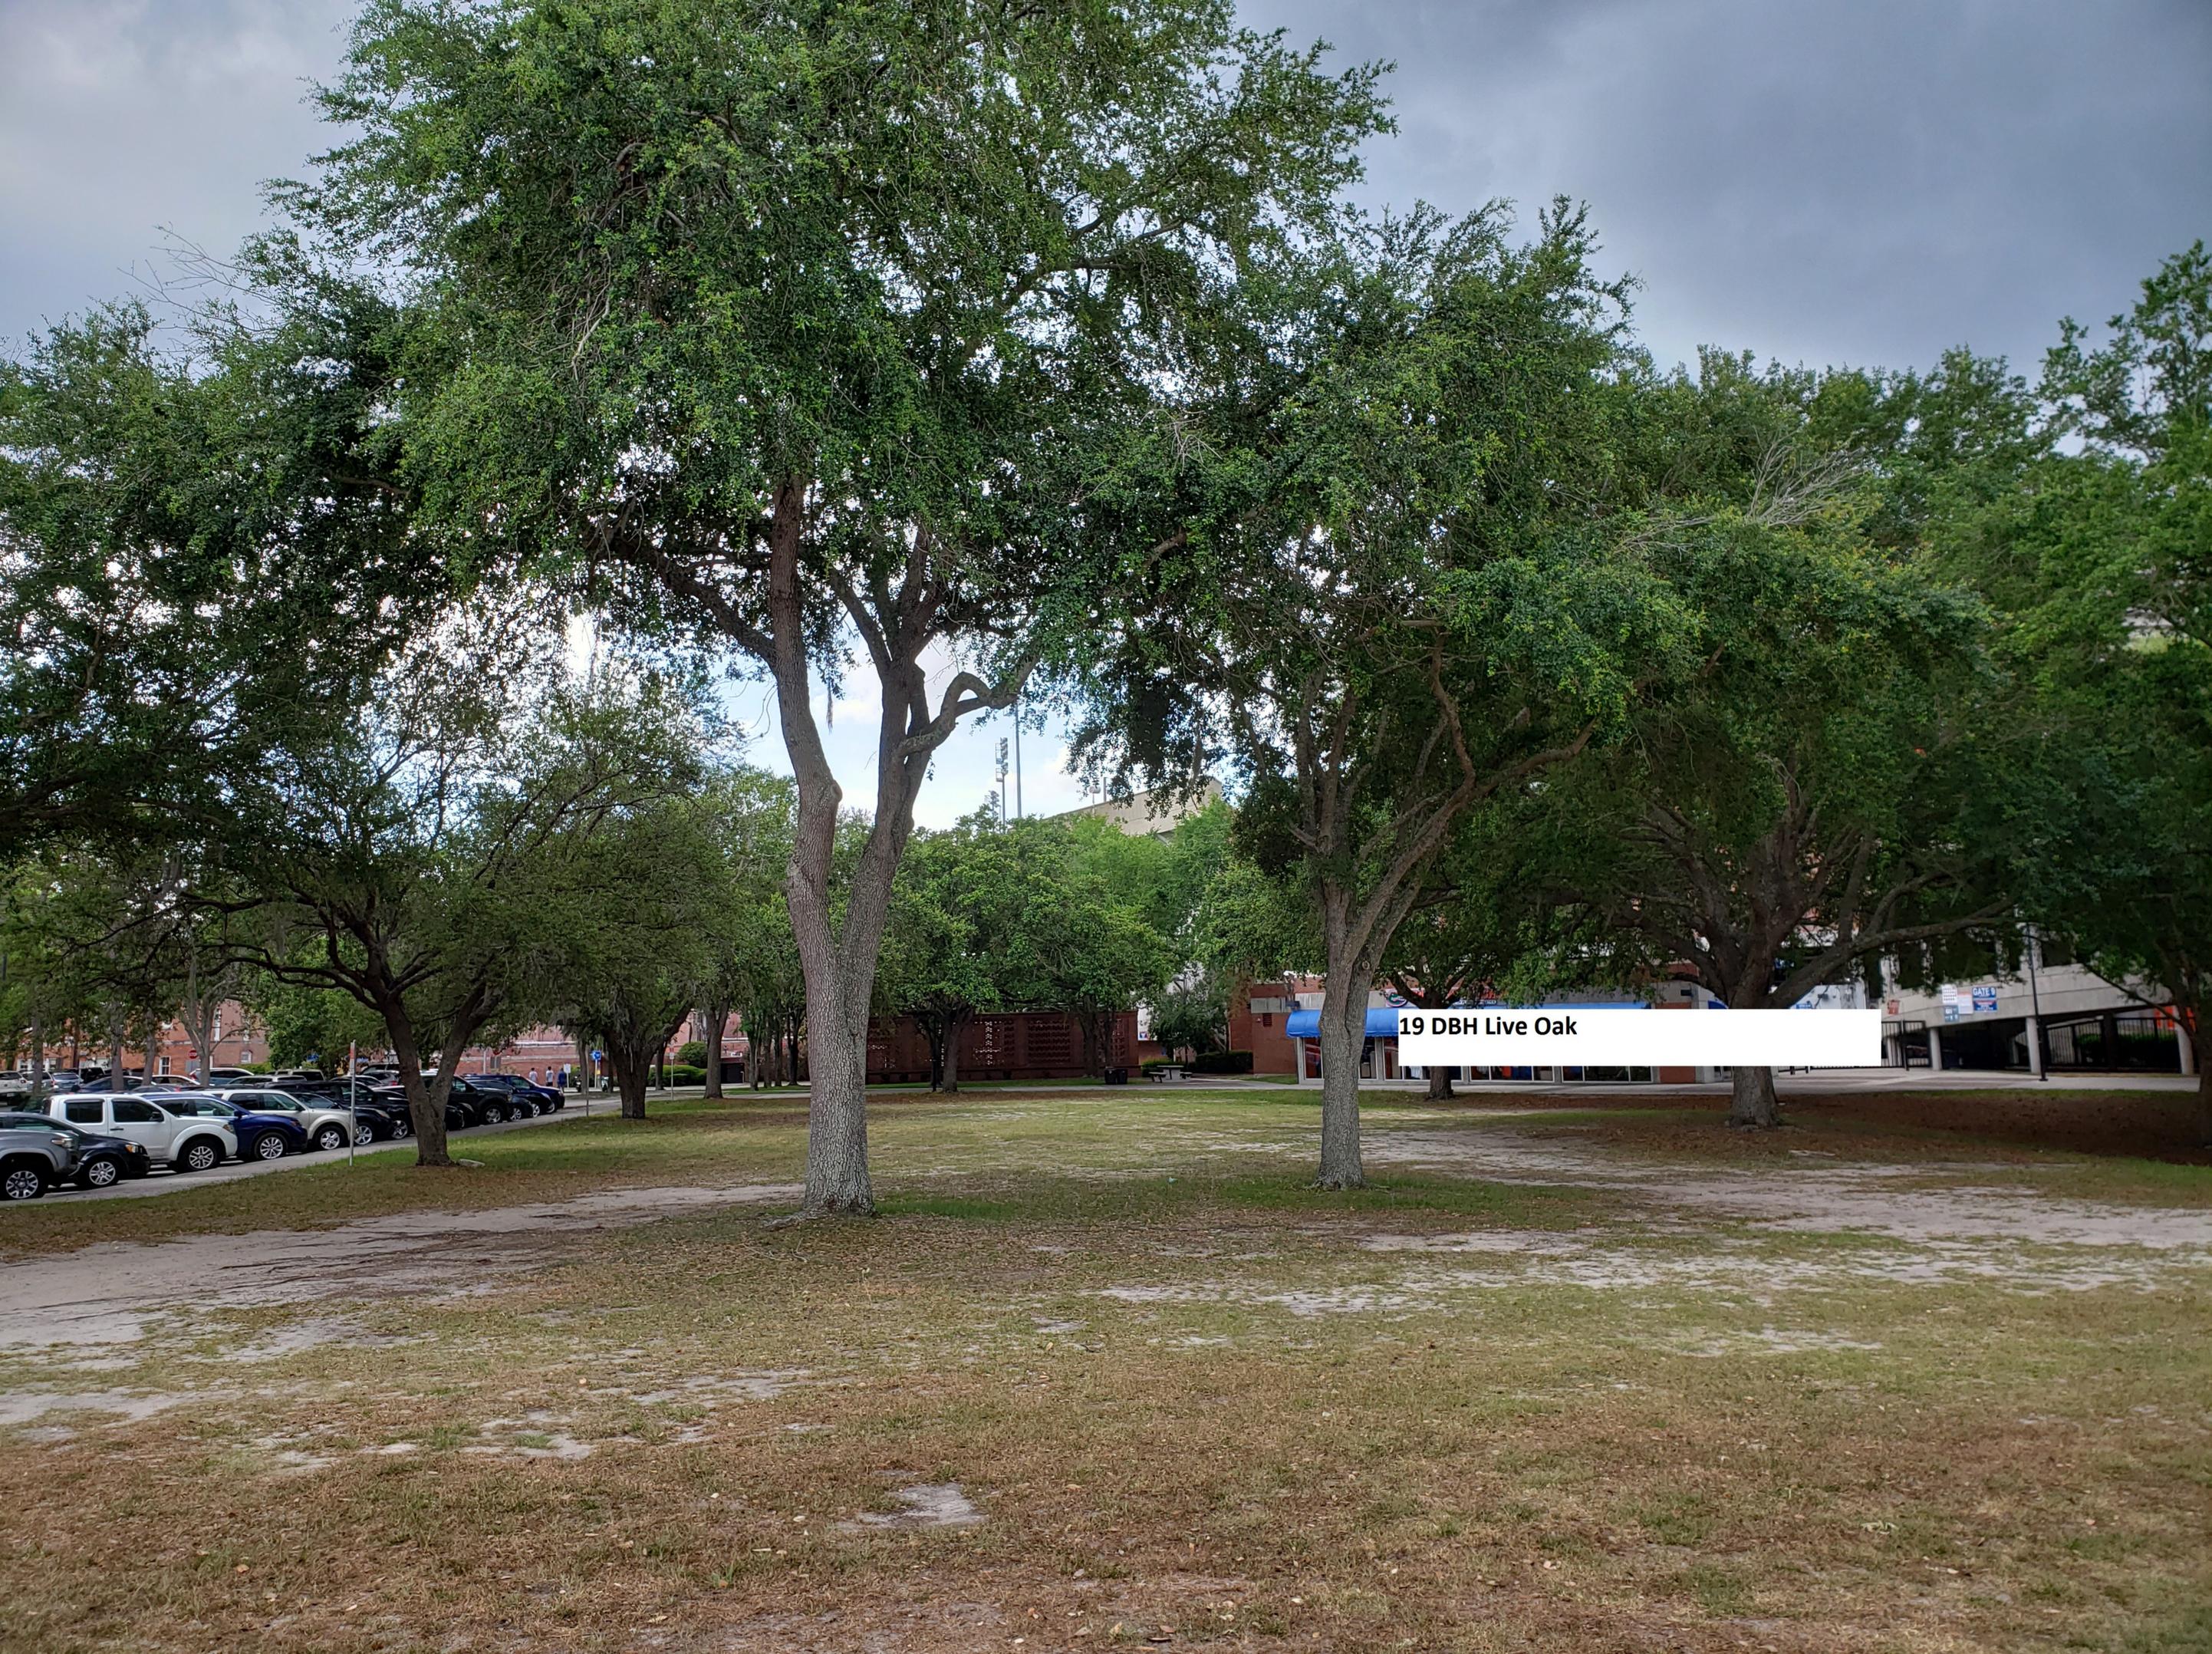
Current conditions: The subject tree is a 48 inch diameter live oak (*Quercus virginiana*) that is likely between 125 - 150 years old. This tree is relatively healthy with one significant issue explained below. There is some canopy thinning. There is major area of decay 4-5 feet wide of the circumference on the main trunk on the NE side, from ground level up to approximately 10 feet. Likely caused by root cutting during sidewalk construction/repair 15-20 years prior and/or a major lightning strike, the scar still visible higher up. Healthy wound-wood is forming on some of the edges of the decay zone indicating that the tree is still vigorous. The decay zone has clear boundaries on the top, bottom and sides. Because of the decay, the strength of the trunk section on the northeast side is significantly reduced.

Discussion: The area around this tree on all sides is used by many students, as many as 160 at one time. Because of the large decay area on the northeast side it's possible in the event of failure that the tree would fall to the southeast and not impact the structure. However nothing can be done to protect students who might be sitting under and around the tree on all sides.

Recommendations: Although this is a significant specimen tree, the failure potential and number of targets qualify this as a moderately hazardous tree. My professional opinion is that this tree should be removed and replaced with another specimen shade tree.
