UF-200
New Public Safety Building
Programing Phase
Lakes, Vegetation and Landscaping
Committee

UF 200 - New Public Safety Building

UF-645

Shealy Drive Parking Deck

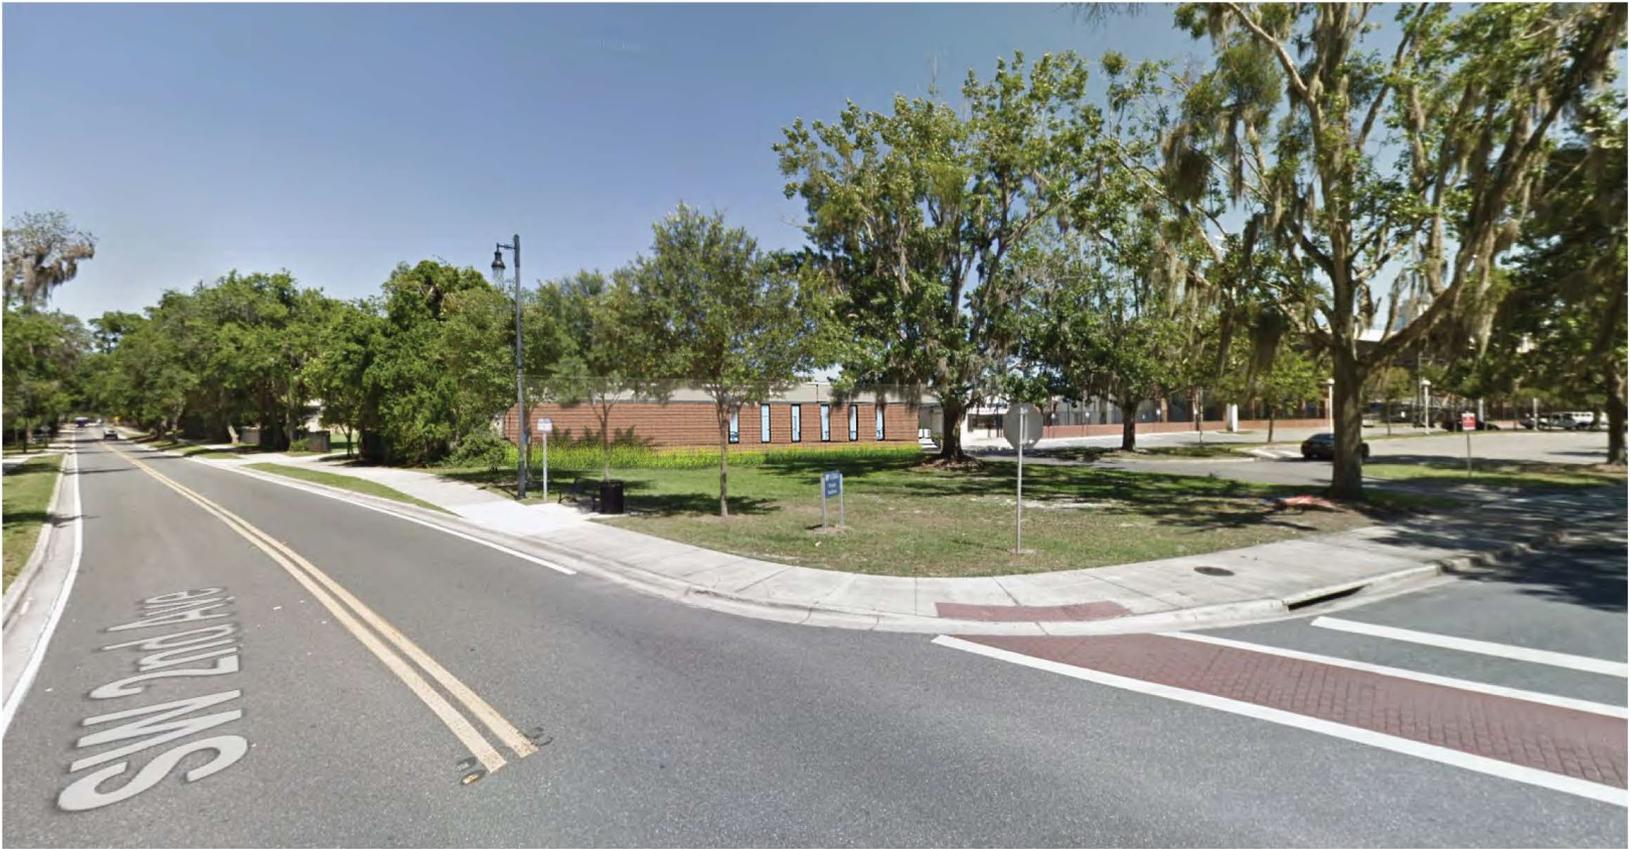
PROPOSED

VIEW FROM SW 2ND AVE. LOOKING EAST

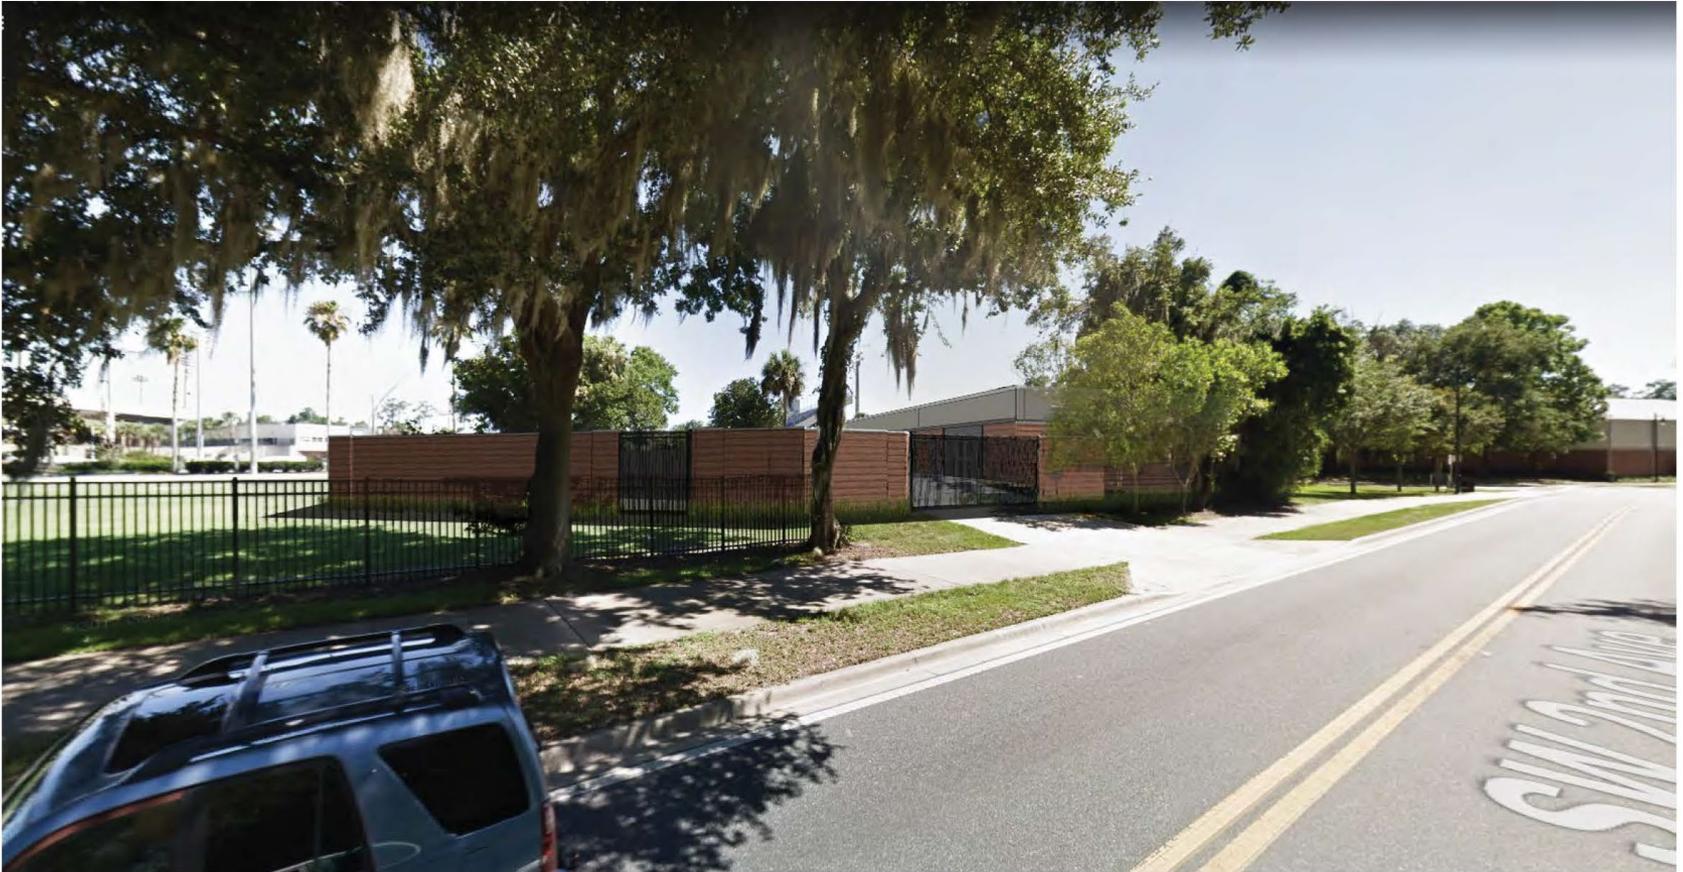
PROPOSED

VIEW FROM SW 2ND AVE. LOOKING SOUTHWEST
