Master Plan for P.K. Yonge Developmental Research School University of Florida

CONDITION ASSESSMENT BUILDING 510 (C)

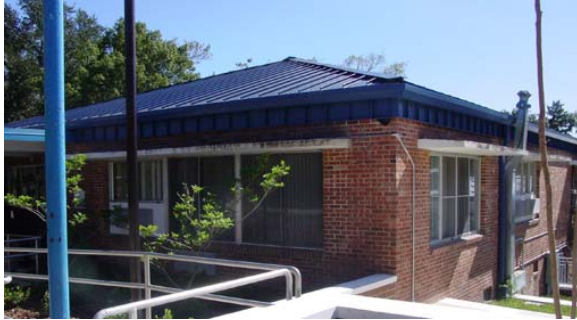
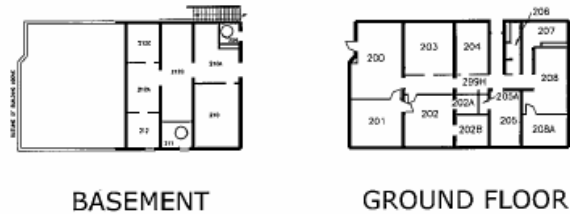
The building appears to have sufficient exiting and the path-of-travel distances are not exceeded. Each level has two remote exits. Fire alarm devices and locations are not to current code. There is no fire sprinkler system in the building. Fire extinguishers were noted throughout the building.

The building finishes, including carpet, acoustic ceiling tile, and paint are in moderate to poor condition. Restrooms finishes are in poor condition and fixtures & partitions should be replaced. Windows have been retrofitted to allow the installation of package wall air conditioning units. Interior doors appear to be original and are in moderate to poor condition.

The building uses PTACs (Package Terminal Air Conditioners) on the upper floor and a combination of PTACs and ductless split systems on the lower floor. The PTACs appear to be in fair to good condition. The ductless split systems appear to be in fair to good condition except for one that did not appear to be operational. The PTACs did not appear to have provisions for outdoor (ventilation) air. The ductless split systems did not have provisions for outdoor air. Outdoor air is required by code. The janitor's closet did not have an EF (Exhaust Fan) and the EFs in the Men's Room and Women's Room did not operate. Restroom and janitor's closet EFs are required by code.

The restroom fixtures are not ADA compliant. The fixtures are old and corroded. The urinal is missing from the men's room.

The electrical distribution system consists of a variety of Federal Pacific Electric panelboards and transformers. All electrical equipment is in poor condition and is well past its useful life, including several pieces of abandoned equipment. The convenience receptacles are in poor condition and are not spaced efficiently.

The phone system is an outdated Northern Telecom Meridian system. It is in poor condition and is past its useful life. Most phone cabling is exposed and shows signs of damage in many areas. The data cabling and accessories are Category 5 and utilize surface raceways to most work outlet locations. There are damaged faceplates and some cabling shows extensive wear and tear. The Data/Comm Room temperature is above the recommended ambient temperature for communication equipment rooms. The room is lacking proper firestops for cabling entering and exiting the space.

There are lay-in fluorescent light fixtures in the conference room and they are in fair condition. There are surface mounted fluorescent fixtures in the storage and equipment areas and they are in poor condition. The lighting levels throughout the building are not adequate per IESNA standards. Also, there are no emergency lights in the building.

The Dukane intercom system incorporates intercom, paging, bell and clock functions for the campus. It is in poor condition and is past its useful life. The wiring is run exposed in the canopies throughout the campus, and shows signs of damage from the environment. There are ceiling mounted speakers in the work areas with push-to-talk call buttons. There are exterior horn speakers at the walkways which are weathered and in poor condition. The digital clocks are old but in fair condition.

Due to the lack of replacement parts, and the cost of refurbishment, the entire distribution system needs to be replaced.

System replacement is recommended due to the limited useful life remaining and the need for state of the art alarming and networked detection and notification capabilities.

The horizontal cabling system should be upgraded to the current Category 6 standards. The work area outlets should be inspected and replaced as necessary. All cables and conduits should be sealed and firestopped as required.

The light fixtures should be replaced with energy efficient lamps to provide 50 foot-candle average illumination levels in all work areas and 35 foot-candles in storage and equipment rooms. Lighting controls should be installed to meet energy efficiency requirements for Chapter 13 of the Florida Building Code. Emergency battery packs should be installed to provide a minimum of 1 foot-candle average illumination along all egress paths.

The entire intercom system should be replaced with a complete educational communication system with voice over IP capabilities.

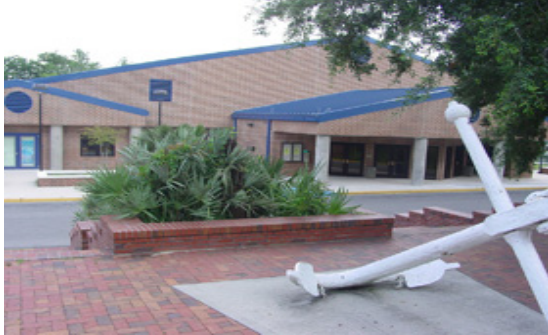
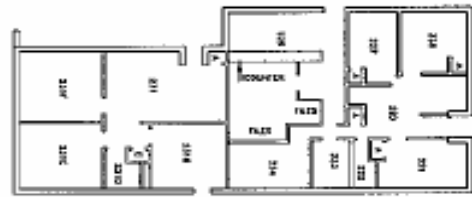
CONDITION ASSESSMENT BUILDING 511 (D)

The building appears to have sufficient exiting and the path-of-travel distances are not exceeded in either portion. Both the guidance and attendance area have two remote exits. Fire alarm devices and locations are not to current code. There is no fire sprinkler system in the building. Fire extinguishers were noted throughout the building.

Carpet throughout the building appears in poor condition. The 2 x 2 acoustical ceiling tiles have been mixed and matched throughout. Paint is in moderate to poor condition. Restrooms finishes are in poor condition and fixtures & partitions should be replaced. Windows have been retrofitted to allow the installation of package wall air conditioning units. Interior doors appear to be original and are in moderate to poor condition.

The building uses PTACs and wall hung package AC (Air Conditioning) units. The PTACs and wall hung package ACs appear to be in fair to good condition. The PTACs did not appear to have provisions for outdoor (ventilation) air. Outdoor air is required by code. The restroom EF in room 223 operated but was noisy.

The restroom fixtures are not ADA compliant. The fixtures are old and corroded.

The electrical distribution system consists of a variety of Federal Pacific Electric panelboards and transformers. All electrical equipment is in poor condition and is well past its useful life. Due to the lack of replacement parts, and the cost of refurbishment, the entire distribution system should be replaced.

The fire alarm system is in fair condition and has 5-7 years of useful life remaining. The existing devices do not provide a complete code-compliant coverage in all areas.

The voice and data cabling and accessories are Category 5 and utilize surface raceways to most work outlet locations. There are damaged faceplates and some cabling shows extensive wear and tear. Many areas are lacking proper firestopping for cable penetrations.

There are lay-in fluorescent light fixtures in the office areas and they are in fair condition. There are surface mounted fluorescent fixtures in the restrooms, storage and equipment areas and they are in poor condition. The lighting levels throughout the building are not adequate per IESNA standards. Also, there are no emergency lights in the building.

System replacement is recommended due to the limited useful life remaining and the need for state of the art alarming and networked notification capabilities.

The horizontal cabling system should be upgraded to the current Category 6 standards. The work area outlets should be inspected and replaced as necessary. All cables and conduits should be sealed and firestopped as required.

The light fixtures should be replaced with energy efficient lamps to provide average illumination levels per IESNA standards. Lighting controls should be installed to meet energy efficiency requirements for Chapter 13 of the Florida Building Code. Emergency battery packs should be installed to provide a minimum of 1 foot-candle average illumination along all egress paths.

The entire intercom system should be replaced with a complete educational communication system with integrated voice over IP capabilities.

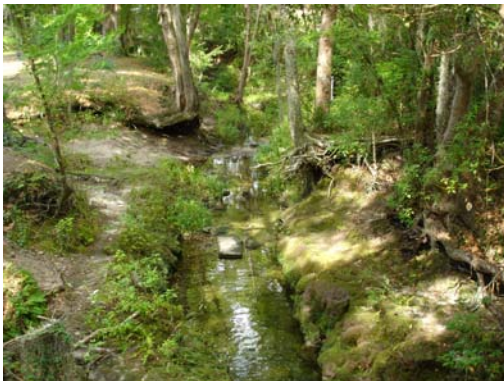
Tumblin Creek traverses the site, running through the Tumblin Creek Watershed to Bivens Arm Lake to Paynes Prairie and eventually to the Floridan Aquifer via the Alachua Sink. Most of the campus buildings ignore the presence of the creek and bank stability is a significant problem. The water quality and natural habitat is impaired because of the lack of a sufficient riparian zone and the poor quality and quantity of vegetation in that area. Two concrete weirs have been constructed to concentrate water flow in the middle of the channel and to minimize the bank scouring.

Tumblin Creek

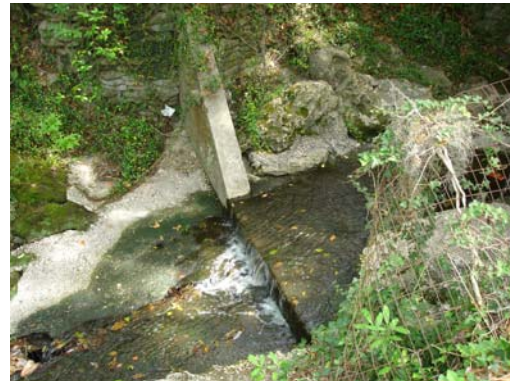
Weir

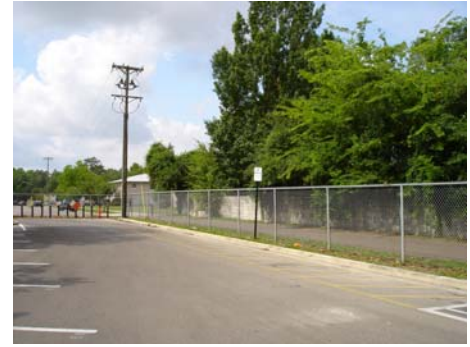
Road closure and fence separation of pedestrian path
